Seismic Evaluation Report

Building 1003

Onizuka Air Station

Mariscal Engineering

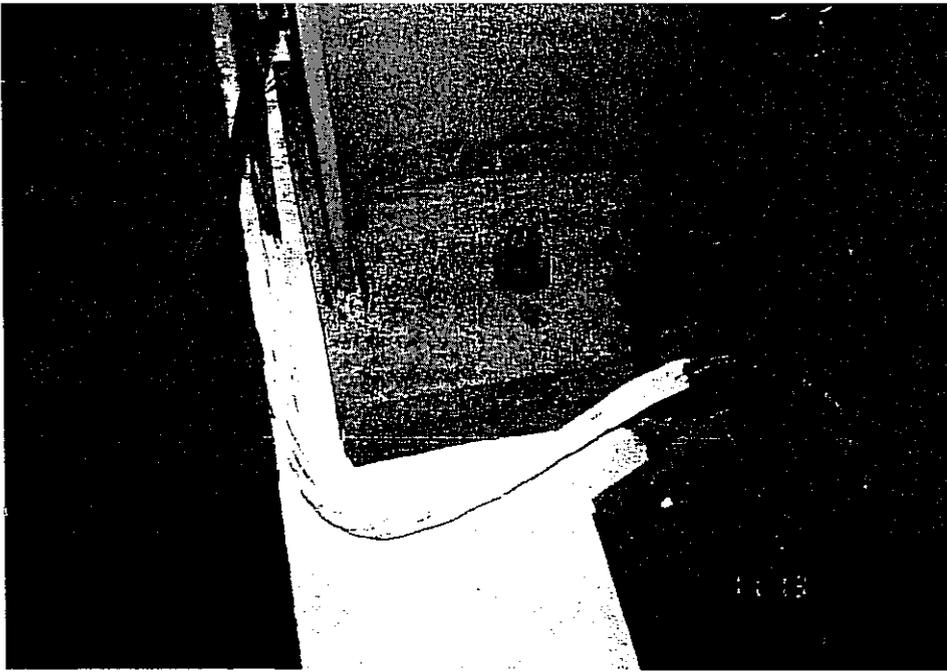
Photo 14. Typical column base anchorage to grade beam as seen on the ground floor mechanical room. Notice the connection and bolt installation are not designed as a moment connection.

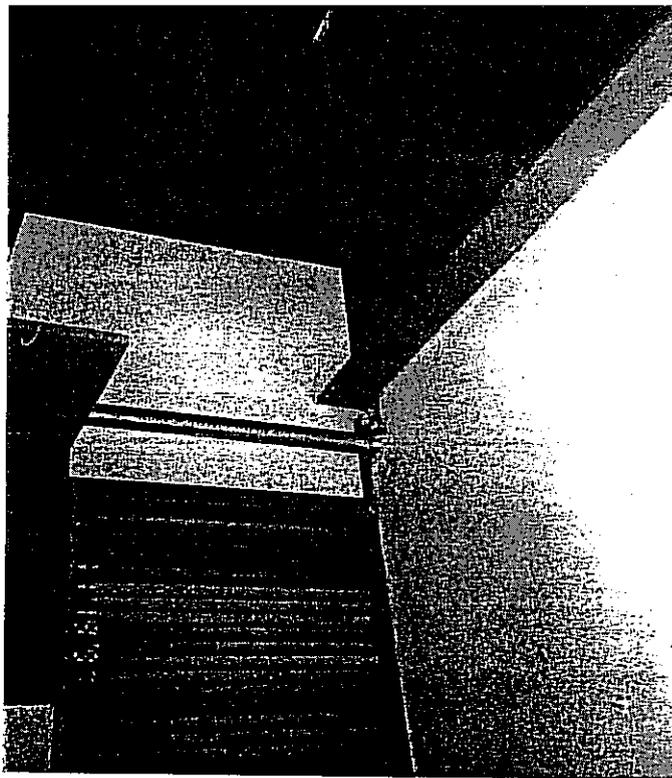
Photo 20. Typical connection of floor beams to column top. Notice the connection is not designed as a moment resistant connection. The steel deck floor is tack welded to the floor joist.

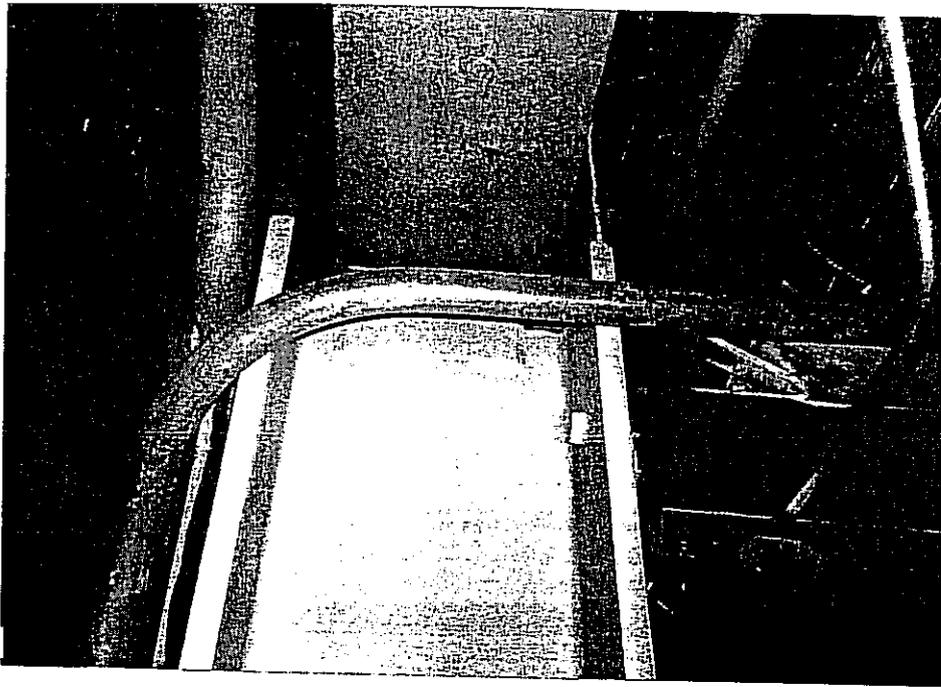
Photo 22. Another view of the connection of floor beams to column top. Again, notice the connection is not designed as a moment resistant connection.

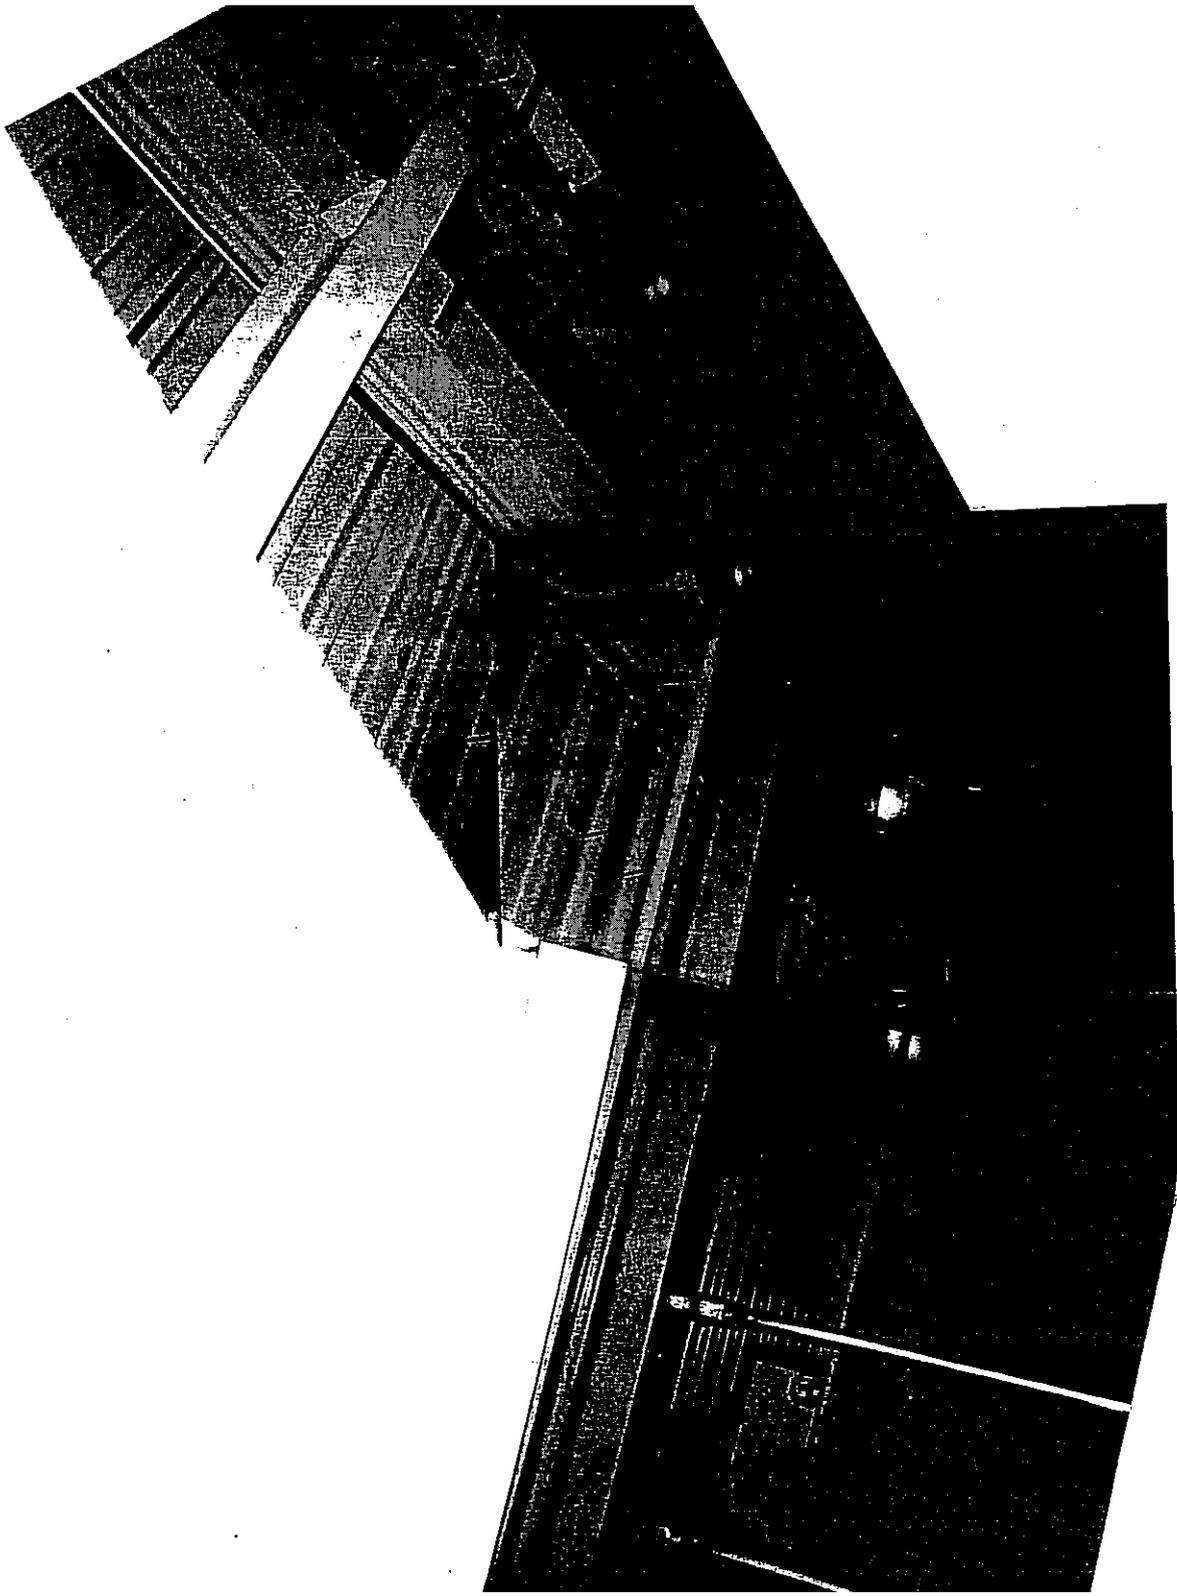
Photo 28. Underneath view of the steel deck roof. The roof consists of a built up roofing over a steel deck. The deck is tack welded to the roof joists. The roof offers limited diaphragm shear resistance to the building structure because of the fact that the tack welds do not qualify as a proper shear connection between the roof deck and the joists.

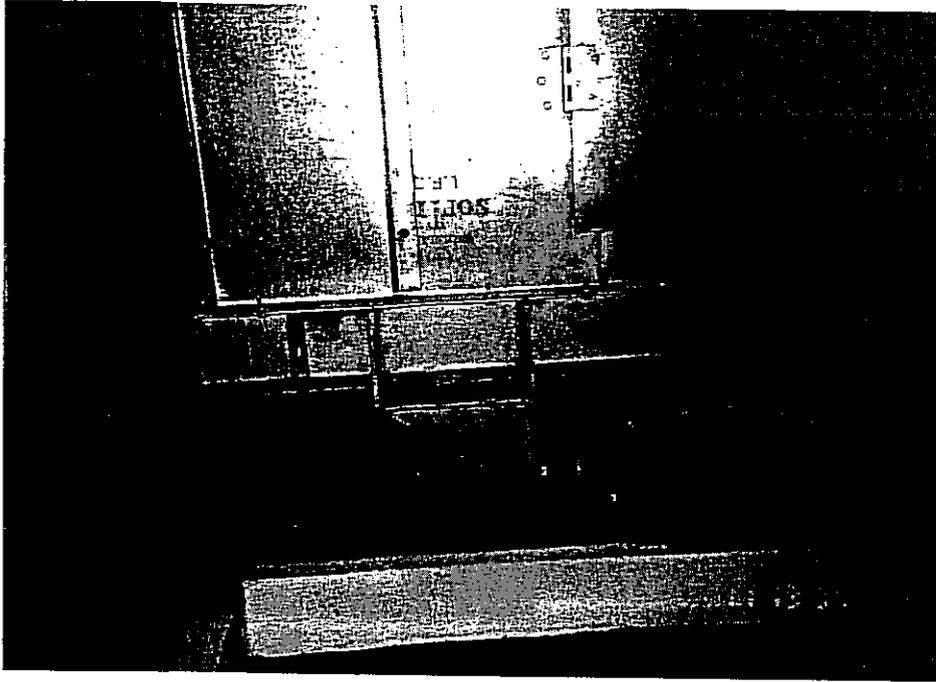
Photo 33. This other type of anchorage for the mechanical equipment provides vibration isolation and allows lateral restraint with a dampening effect. This anchor type is recommended to limit horizontal and vertical motion while absorbing stresses to minimize damage to equipment, piping connections or foundation.

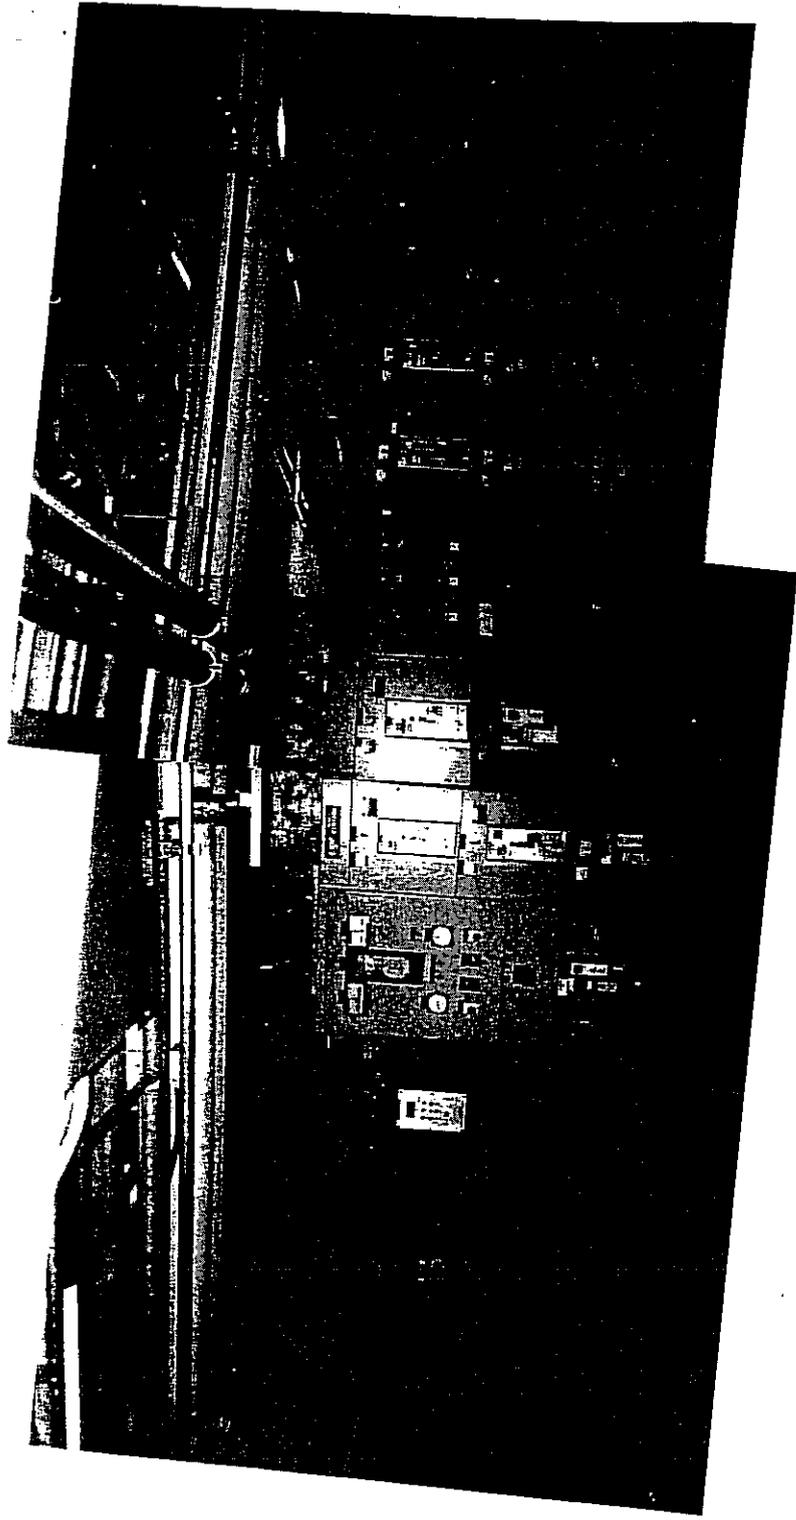
Photo 36. Electrical and mechanical equipment in the Mezzanine floor. It is unknown whether the equipment is anchored and the anchors are concealed within the metal cabinetry. The piping and conduits above are properly attached.

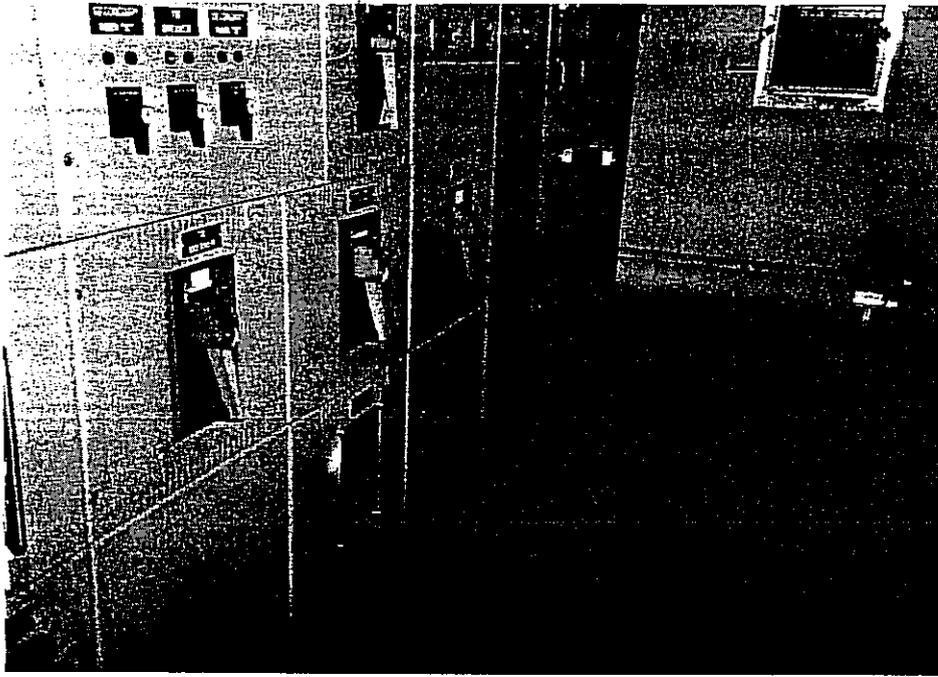
Photo 37. More equipment and furniture in the Mezzanine floor with rigid anchors directly attached to the floor. There is no pad under the equipment. The floor shows minor cracking as signs of distress caused by the anchors.

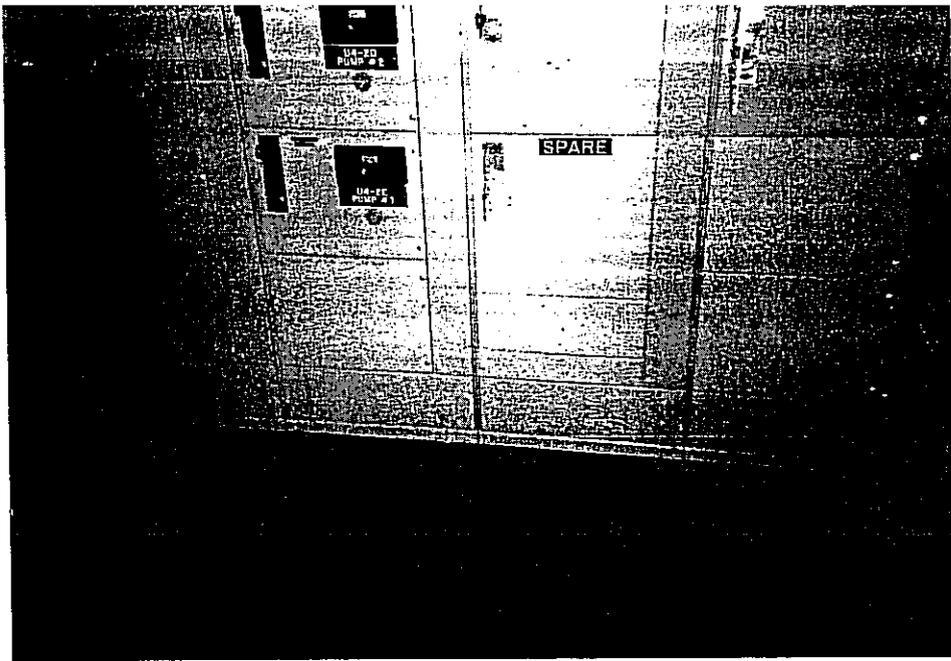
Photo 39. More equipment in the Mezzanine floor. It is unknown whether the equipment is anchored and the anchors are concealed within the metal cabinetry.

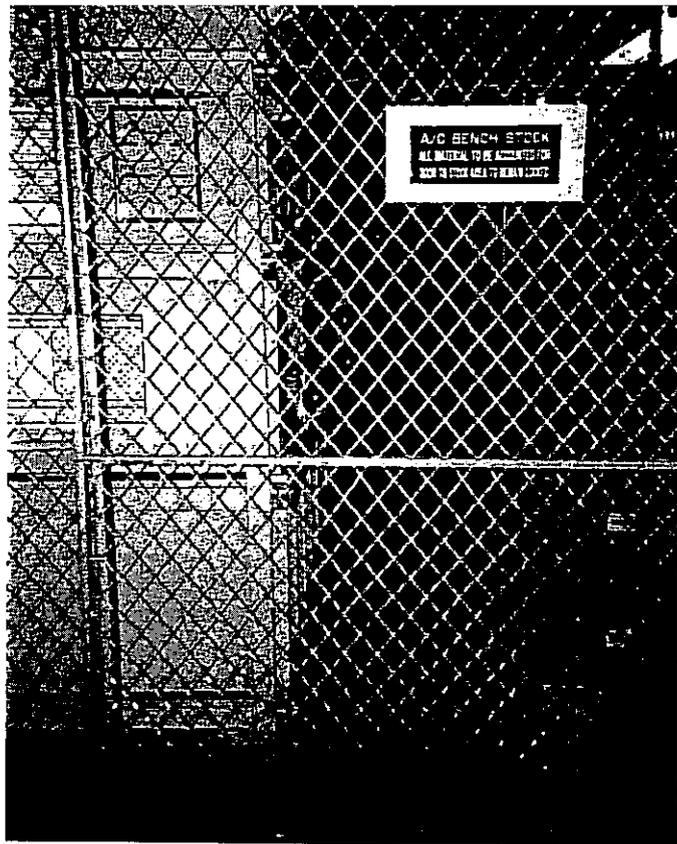
Photo 43. Designated equipment storage areas are fenced with chain-link fences properly anchored at the bottom. Anchoring of the top is recommended.

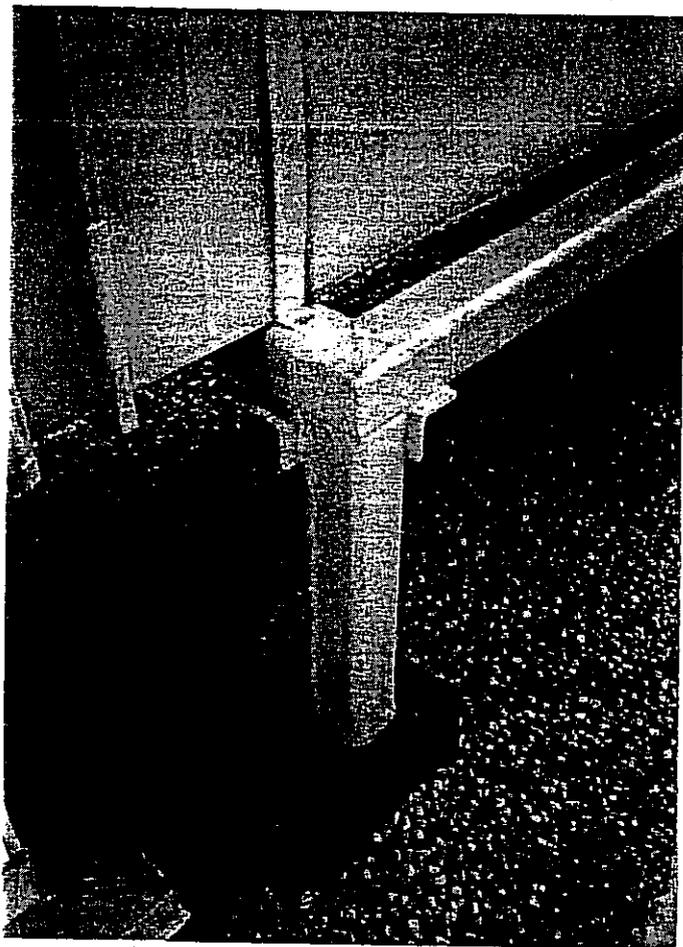
Photo 49. Some equipment supports at the roof level are rigidly anchored to the roof structure. Lateral bracing in both directions is recommended for legs supporting equipment over 18 inches above floor level.
