12-0013

May 9, 2012

SUBJECT: City of Sunnyvale Lawrence Expressway Trunk Sewer Main Evaluation

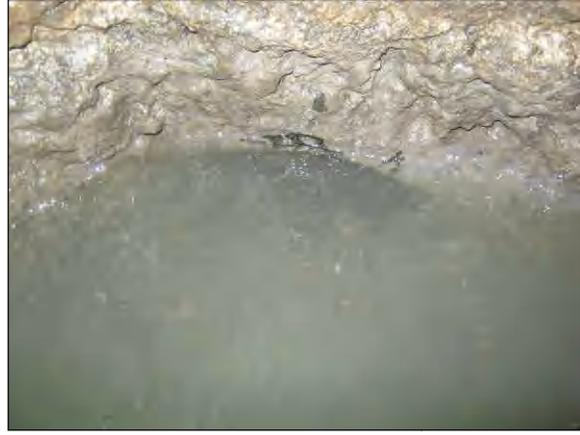
Photo 6. Manhole 536-203. 10-inch diameter apparent VCP influent from the east (submerged).

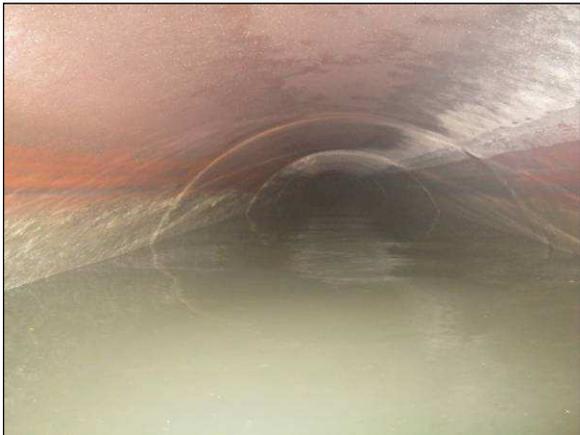
downstream of the siphon near the north side of the railroad track. The 39-inch vitrified clay pipes show no visible signs of deterioration. Sediment in the 39-inch diameter vitrified clay influent pipe is 5½ to 7 inches deep.

Photo 7. Manhole 536-203. 39-inch diameter VCP influent from the south.

- ❖ The sediment buildup on the downstream (north) side of the Tasman Drive siphon under the light rail tracks indicates the siphon may need cleaning.
- ❖ The City of Sunnyvale trunk line north (downstream) of Manhole 425-211 does not require rehabilitation at this time. The pipe crowns show only minor ⅛ to ¼-inch deep thin surface peeling and scaling losses.

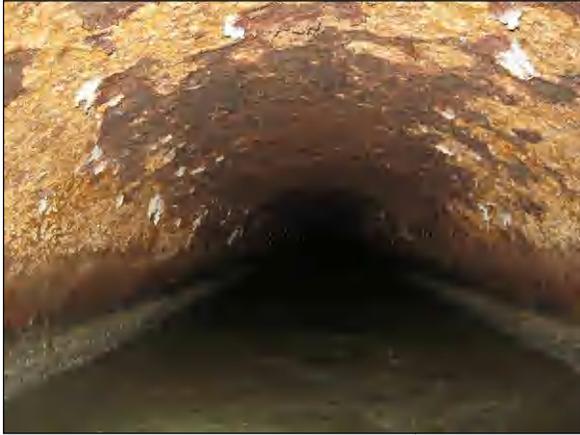
Photo 12. Manhole 496-218. 36-inch diameter concrete pipe effluent to the north. Thin peeling of shallow alteration zone.

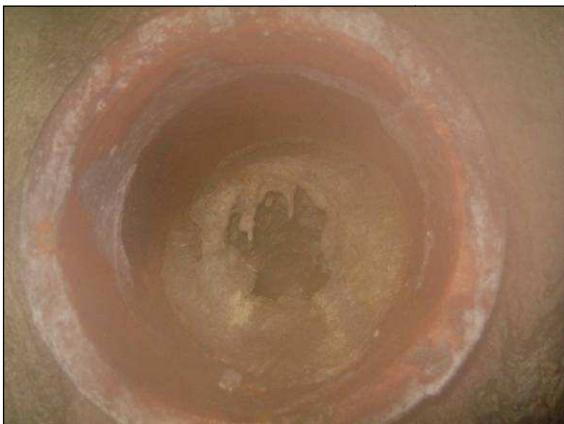
Photo 22. Manhole 425-211. 6-inch diameter VCP drop inlet from the west. Abandoned.

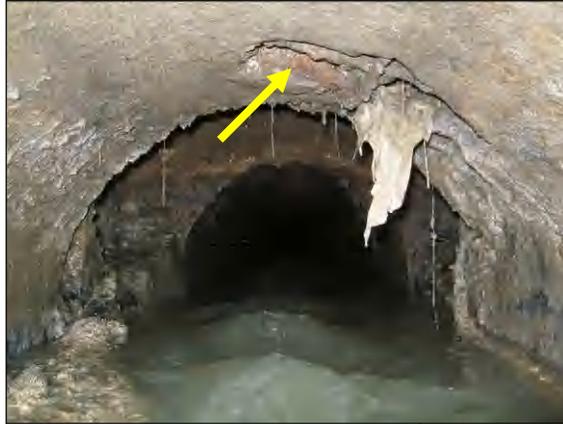
- ❖ The manholes at the Arques Avenue intersection (376-202 and 376-203) and Manhole 345-201 at Miraloma Way display more prevalent crown concrete deterioration. Exposed concrete aggregate is visible. Two crown samples (376-202 and 345-201) gave pH values of 3.5 and 3.8, indicating strong cement paste deterioration, most likely by atmospheric hydrogen sulfide attack.

Photo 24. Manhole 376-202. 26-inch diameter concrete pipe influent from the south. Note exposed aggregate on crown.

- ❖ The point defect in the crown of the 26-inch concrete pipe between Manholes 376-202 and 376-203 should be repaired. The cause of the point defect is unknown although it is possible the condition leading to crown wear and exposed aggregate may be remedied by eliminating the surcharging at Manhole 345-211 upstream. Other point defects could be present in segments of piping out of sight from the manhole vantage point. Therefore, it is recommended that CCTV documentation of the trunk line be performed.

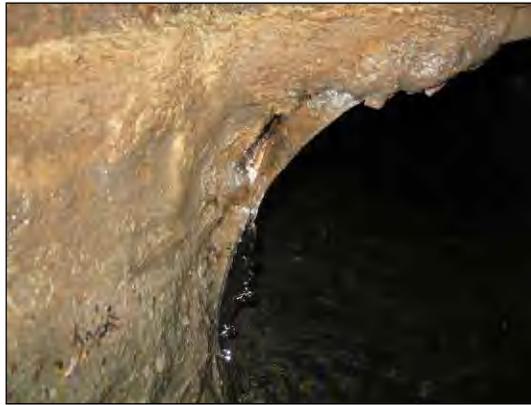
- ❖ Groundwater infiltration is occurring at the 10 o'clock edge of the 21-inch diameter HDPE effluent pipe in Manhole 376-202.
- ❖ The southernmost manhole that was assessed, Manhole 345-211, is surcharged. The manhole atmosphere had a hydrogen sulfide odor. The metal lid and ring on the topside concrete collar are corroded. The surcharged condition at Manhole 345-211 was noted on April 1, 2012, at 4:15 p.m., and again on the night of April 18, 2012 at 11:00 p.m. This appears to be a chronic condition. Hydrogen sulfide may also be collecting in piping and manholes upstream.

Photo 26. Manhole 376-202. 21-inch diameter HDPE pipe. Groundwater infiltration

- ❖ The groundwater infiltration around the 21-inch diameter HDPE pipe in Manhole 376-202 requires repair. Groundwater and other sources of inflow and infiltration on the trunk line should be evaluated by conducting flow monitoring during wet weather. Results from a flow monitoring study can be used to identify inflow and infiltration as well as capacity constraints in the trunk line.

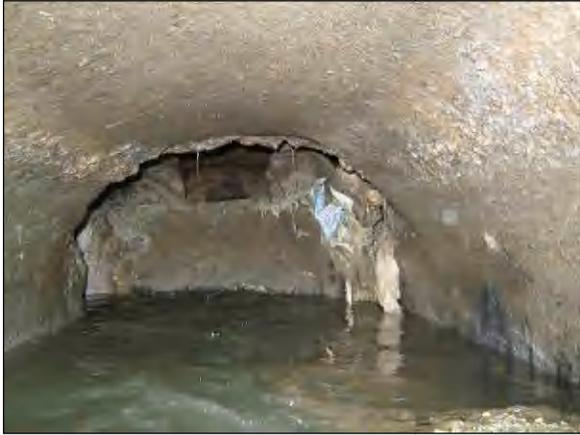
Photo 28. Manhole 376-203. 26-inch diameter concrete pipe effluent to the north. Note weir in Manhole 376-202 that channels flow into the 21-inch diameter HDPE effluent pipe.

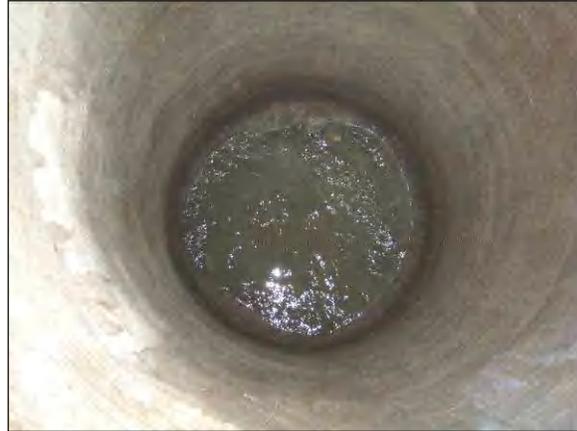
Photo 37. Manhole 345-211. Plan view showing surcharged condition.

- ❖ The surcharged Manhole 345-211 is a concern. This condition restricts the pipe headspace air flow and may be allowing hydrogen sulfide gas to collect in the piping and in manholes immediately upstream. V&A recommends remedial action to correct line obstructions or possible sags that may be causing this manhole to surcharge.

- ❖ Due to the surcharge in Manhole 345-211, pressurized air conditions could exist in piping and manholes upstream. If atmospheric hydrogen sulfide gas is present in the manhole, a possible release of odors could occur. Should efforts to alleviate the surcharged condition be unsuccessful, it is recommended that an air pressure and sulfide monitoring study be conducted to evaluate the potential for odors.
