Library *of the* Future

Existing Facility Assessment

Published Date, December 13, 2006
Revised Date, June 28 2007

ANDERSON BRULÉ ARCHITECTS

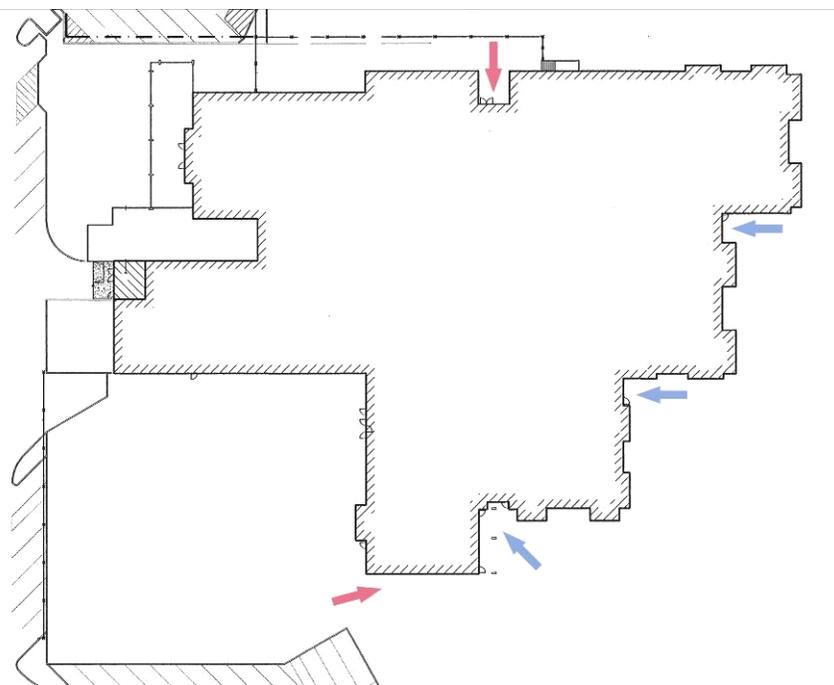
Some existing pedestrian pathways from sidewalks to building entrances do not meet the correct grade requirements for accessible path of travel. These conflicts should be remedied to comply with the Americans with Disabilities Act requirements. Refer to the red arrows on the site plan below for locations.

Some exit paths from the building are not adequate; the sidewalks terminate right outside of the exit doors and do not continue to the public sidewalks in accordance with fire code requirements for exiting path of travel. This issue should be remedied to comply with code requirements. See the blue arrows on the site plan below for locations.

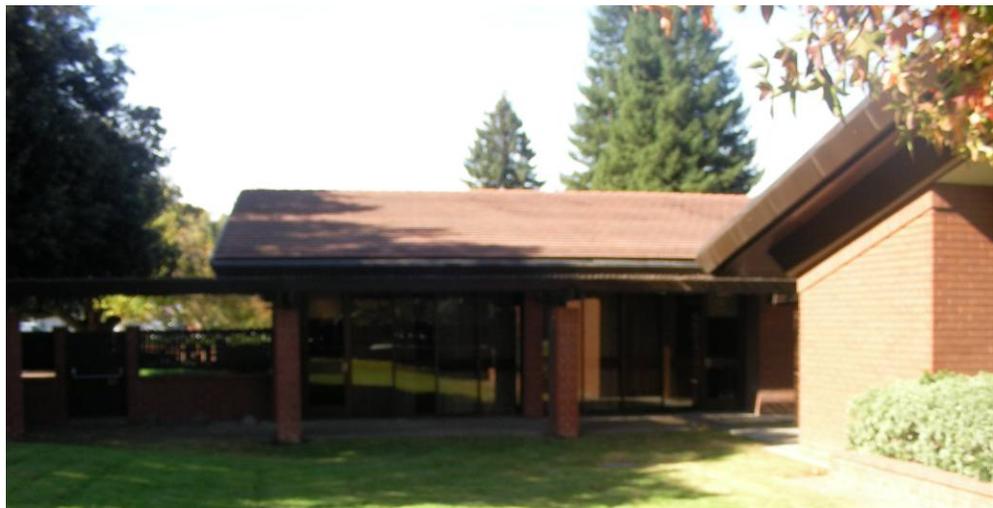
There are large overhangs at the perimeter of the building; the eaves are finished with exposed wood siding. There is an existing sprinkler system intact to protect this wood finish from fire damage. There have been problems with gutter blockage that forces water to stream over the edge of the gutter and has caused flooding at the storefront exits in the past.

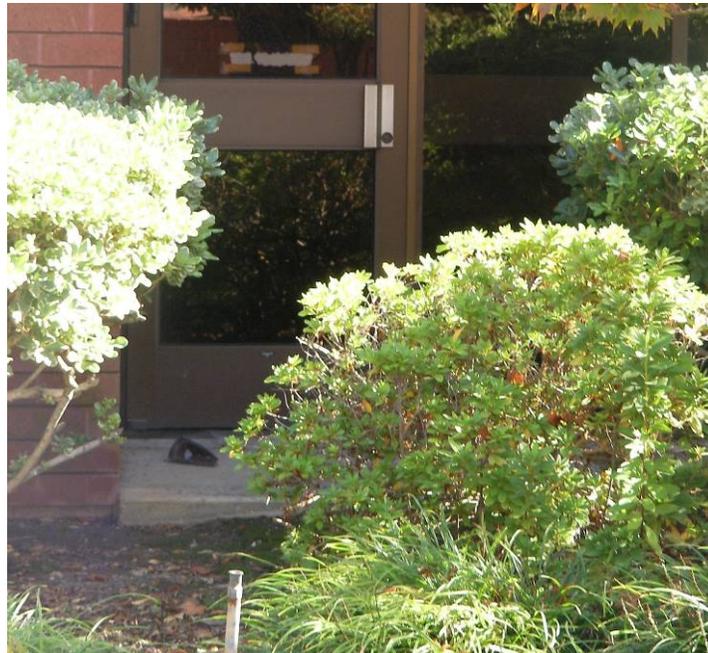
The main entry has a drainage trench to capture rain runoff, but the staff indicated problems with water infiltration and of consistent issues with pedestrians tracking significant water into the building during rain.

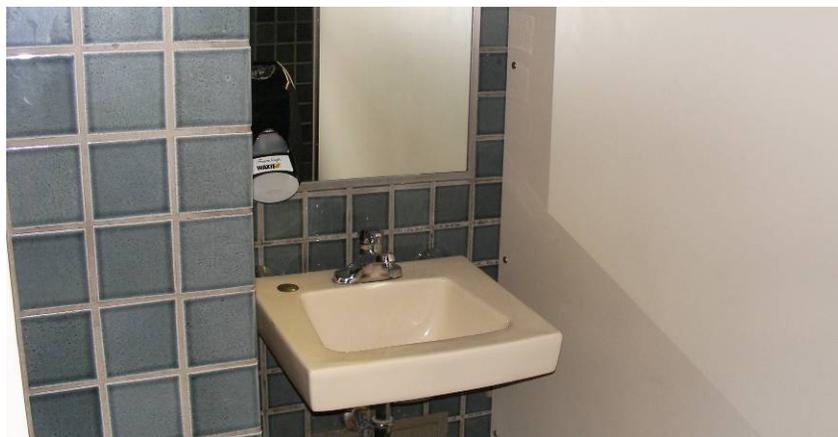
The existing library is well used by the community of Sunnyvale. The facility and the finishes have worn due to the amount of use the facility receives. In general, the toilet room finishes are worn and damaged. Lighting in the toilet rooms does not appear to be adequate.

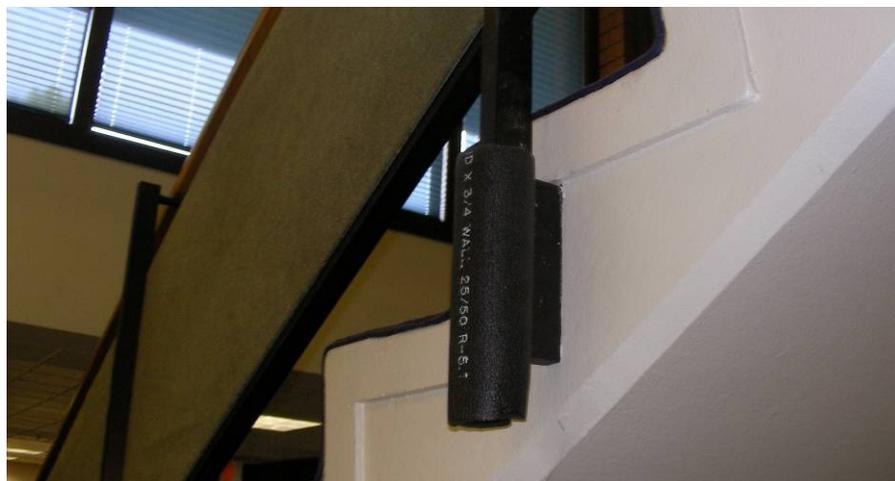
Exit signage is located at each exit door. Stairs to the mezzanine do not appear to meet current code; the landing at the main entry doors at the mezzanine does not accommodate the appropriate clear distance for accessibility requirements. There is a head-height clearance concern at the underside of the stairway to the mezzanine and there have been temporary measures taken to cover exposed sharp stair handrail post protrusions.

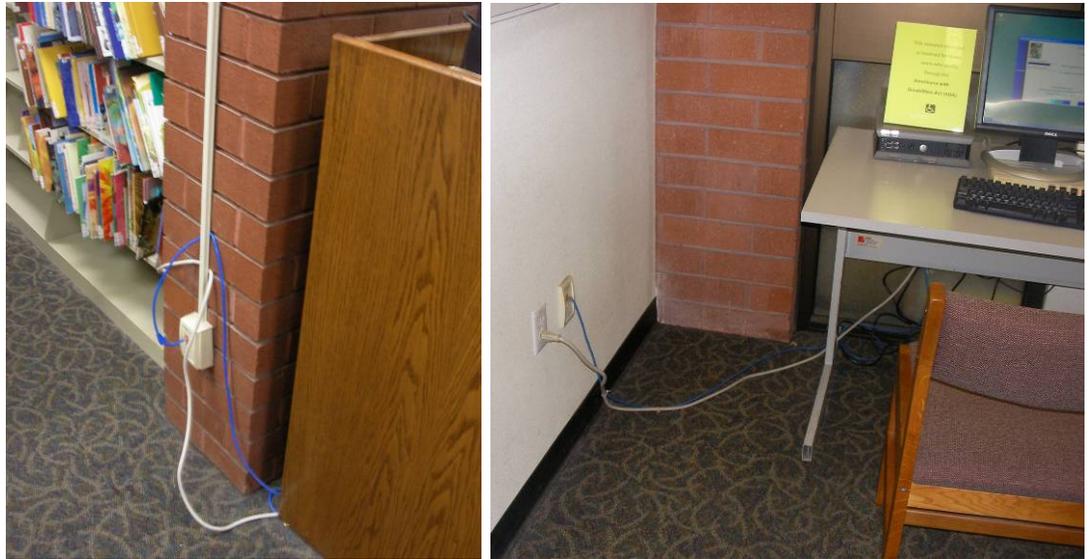
Some of the office furniture layouts require that the existing window wall systems are covered with opaque covering, which obscures and blocks light transfer. The brick wall finish does not allow for concealed technology conduit and equipment and therefore a consistent issue with technology conduit and wiring remaining exposed exists.

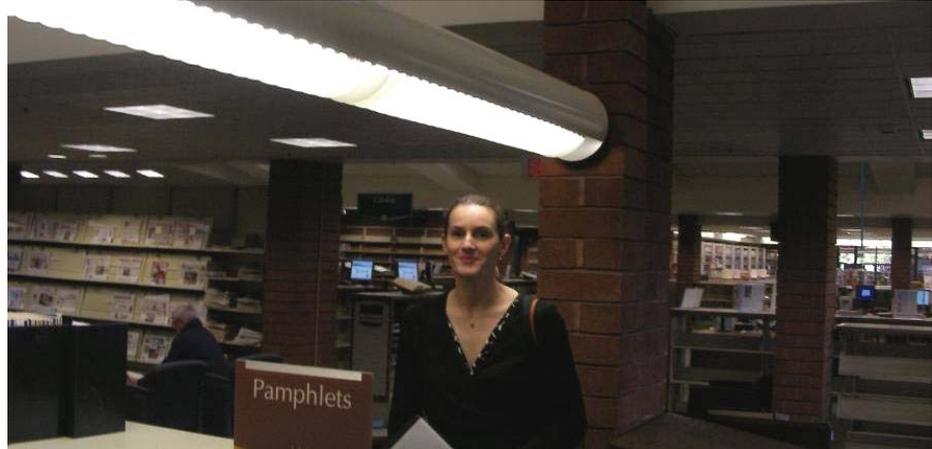
Some light fixtures have been installed too low and cause head height clearance issues. These should be relocated to accommodate the appropriate clearances. The location shown below is adjacent to the stairs leading to the mezzanine, but other lighting throughout the library should be reviewed.
