Tree Impact Analysis

Sunnyvale Town Center Block 3 Landscape and Parking Lot Plan Set Iteration 12/19/2016

Report:

WLCA

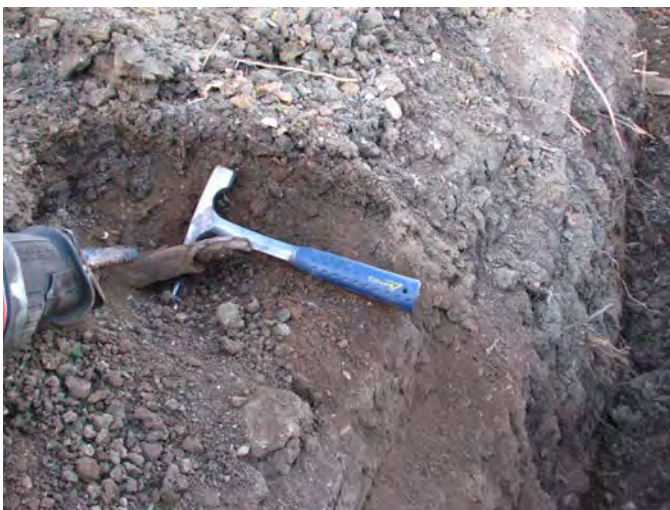
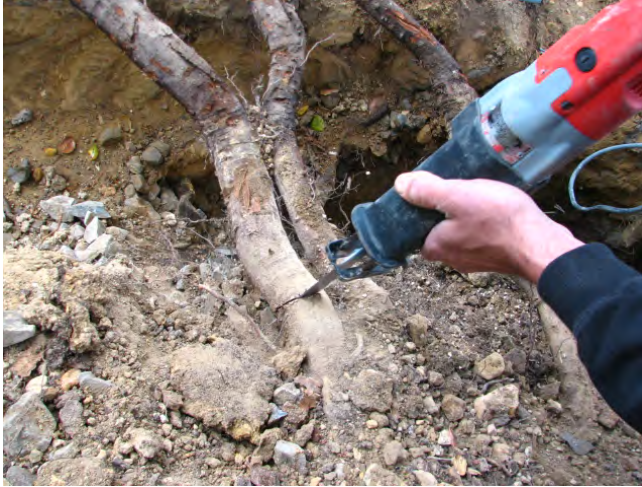
If a root is shattered or broken, then back-dig around the root using a small hand tool until a clean unbroken section of root is visible, and prune the root at that location to remove all shattered material (see images below).

Prune all roots at right angle to the root growth direction (i.e. cut "square" per the images below).

Backfill immediately (same day) with parent soil and water thoroughly to saturate the uppermost 24-inches of the soil profile.

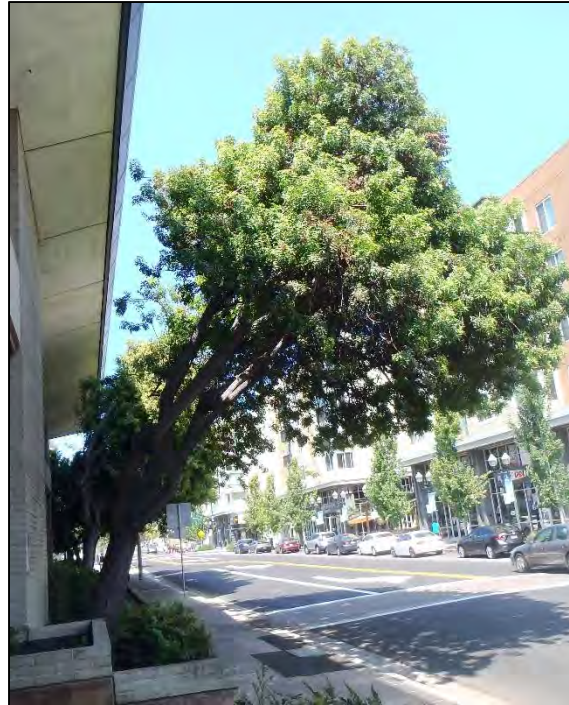
Photo 1: Looking west at Brazilian pepper #286. The tree was typical of the Brazilian peppers growing along the north side of the Macy's building. It leaned and had a one-sided crown to the north as a result of pruning/topping for building clearance and phototropism.
