URS - Phase I Environmental
Site Assessment, June 17,
2009

PHASE I ENVIRONMENTAL SITE ASSESSMENT
Fair Oaks Industrial Complex
1010 Morse Avenue
Sunnyvale, California

URS Project No. 28645105

June 17, 2009

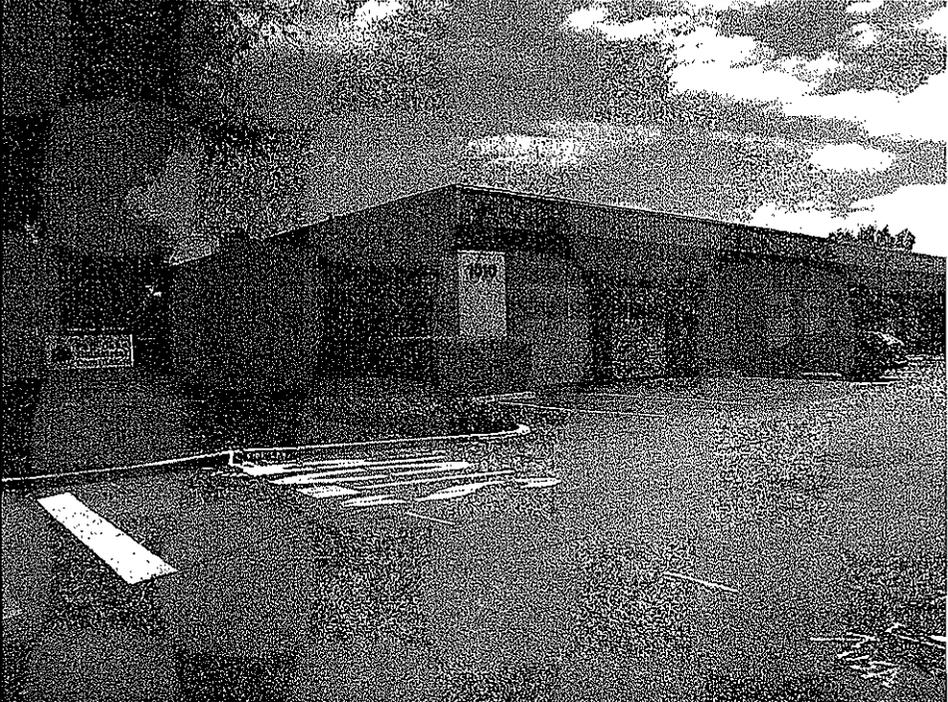
Photo No: 1	Date: 05/06/09

Direction Photo Taken: Northeast		
Description: Asphalt paved site entrance and parking lot around site building.		
Photo No: 2	Date: 05/06/09

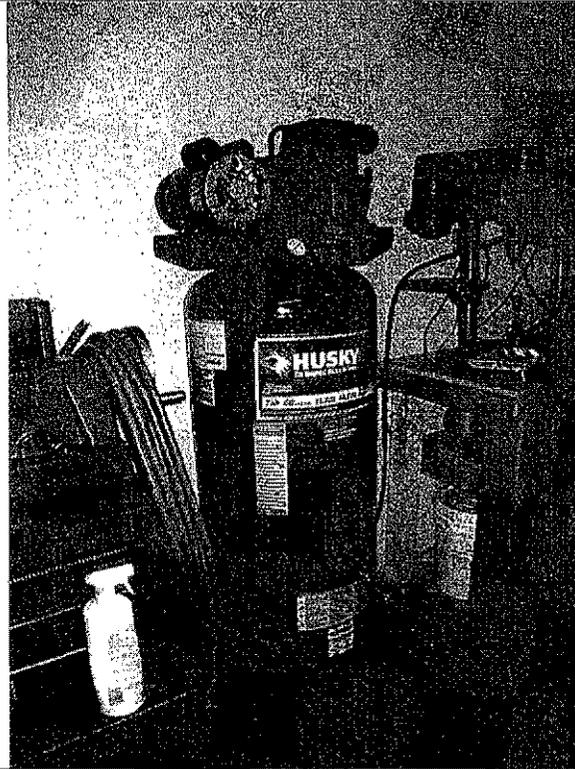
Air compressor used by
the machine shop suite.

No reportable quantities (above 55 gallons for liquids, 500 pounds for solids, or 200 cubic feet for compressed gases) of hazardous materials (including hazardous waste) are used, stored and/or generated on site. Machine shop tenants (only one was visited) have small amounts of lubricating oil and generate very little waste (less than 60 gallons per year). Less than five gallons of acetone were observed at 1020 Morse Avenue, in the warehouse portion of ExcelFab. ExcelFab also contained an air compressor, which according to its specifications produces 51.7 cubic feet of compressed air at 125 psi, and propane-powered forklift.

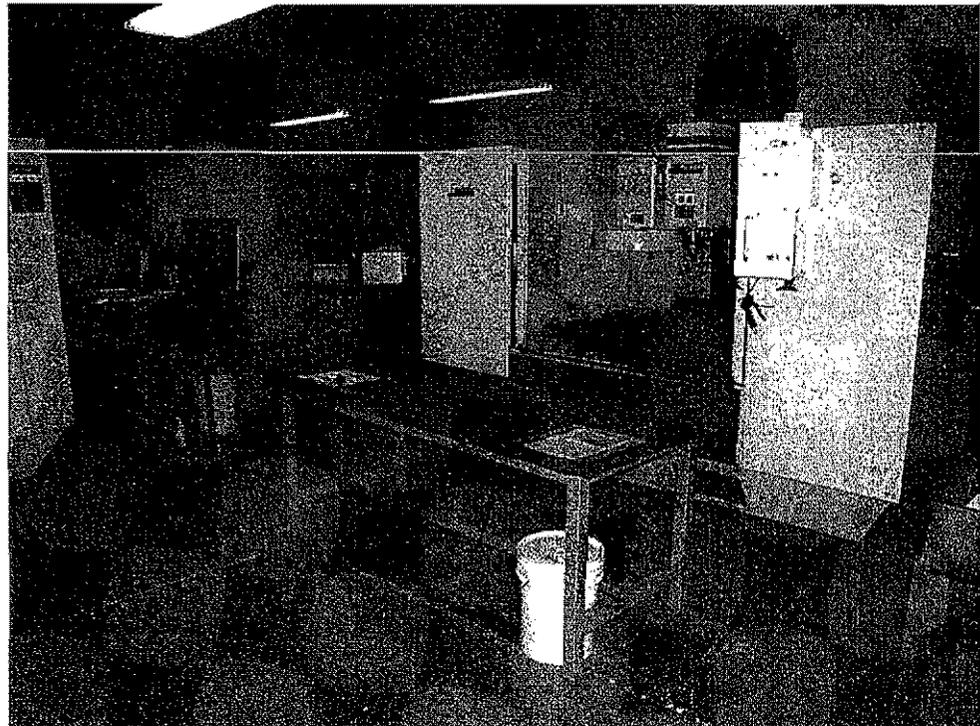
Photo
No:
4

Equipment used in
machine shop suite.

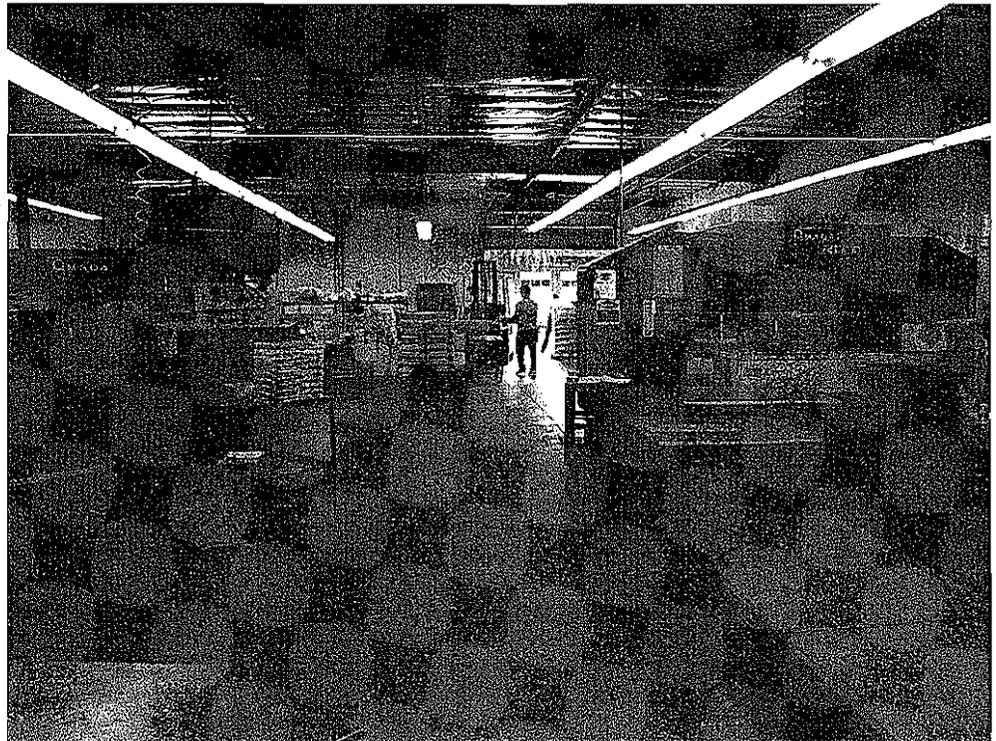
Photo No:
6

Fabrication area of
ExcelFab, located at
1020 Morse Ave.

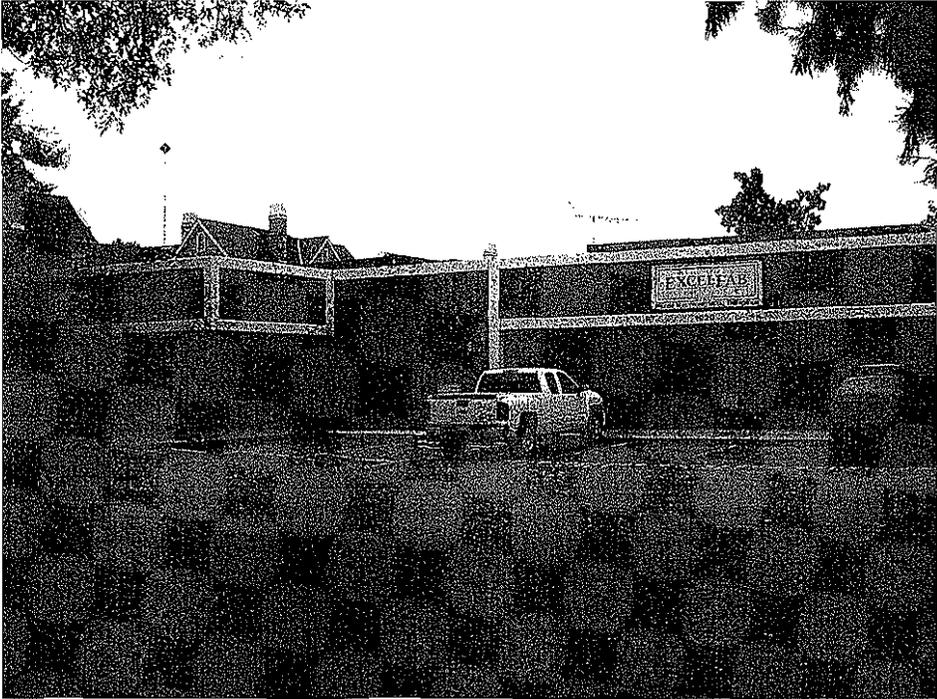
Photo No: 9	Date: 05/06/09

Direction Photo Taken: East		
Description: Front of the site buildings with addresses 1020 and 1024 Morse Ave.

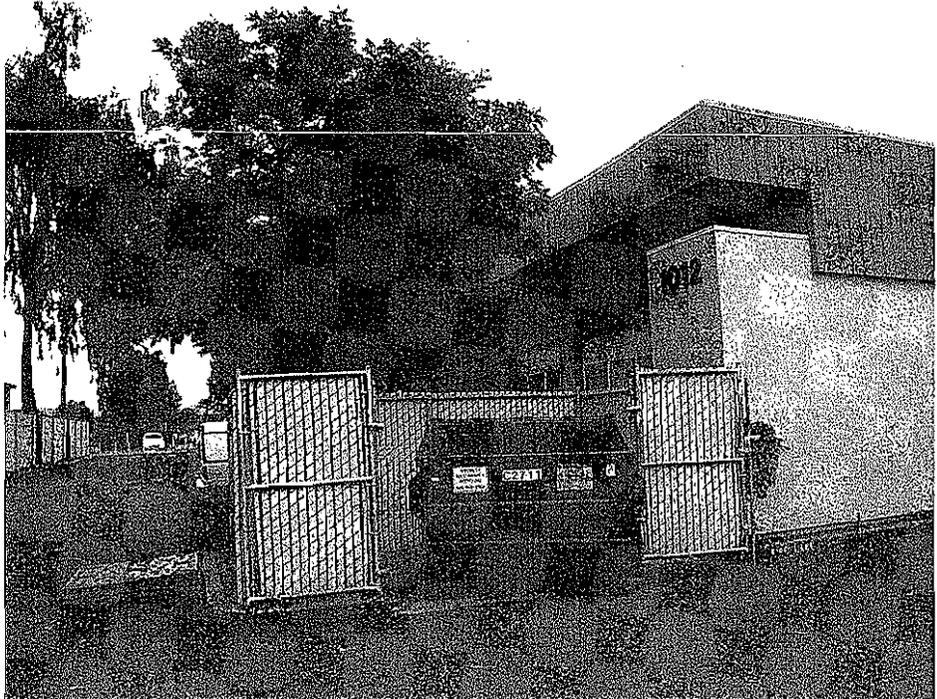
Photo No: 10	Date: 05/06/09

Direction Photo Taken: Southwest		
Description: Municipal/waste dumpster at the corner of multi tenant building.
