Seismic Evaluation Report

Building 1003

Onizuka Air Station

Mariscal Engineering

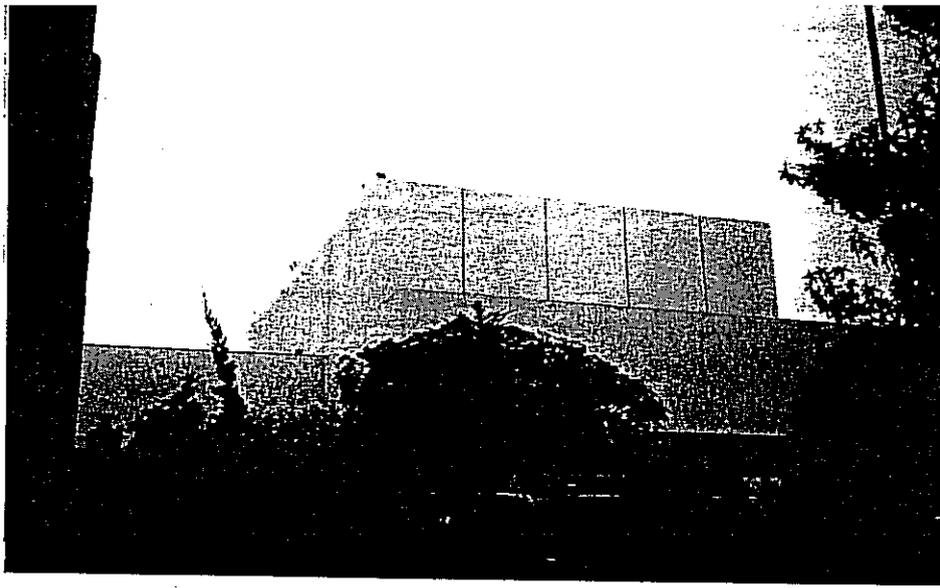
Photo 1. North view of Building 1003 behind, surrounded by Buildings 1001 and 10031 in foreground.

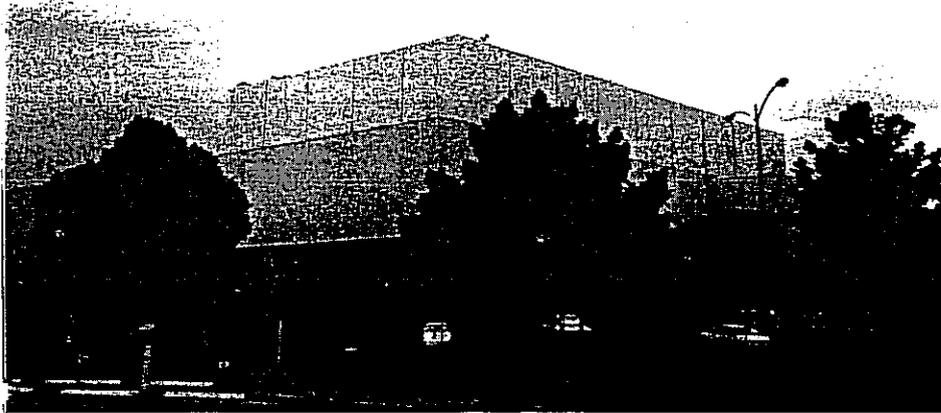
Photo 3. Northwest view of Building 1003 behind, surrounded by Buildings 10031 and 10032 in foreground.

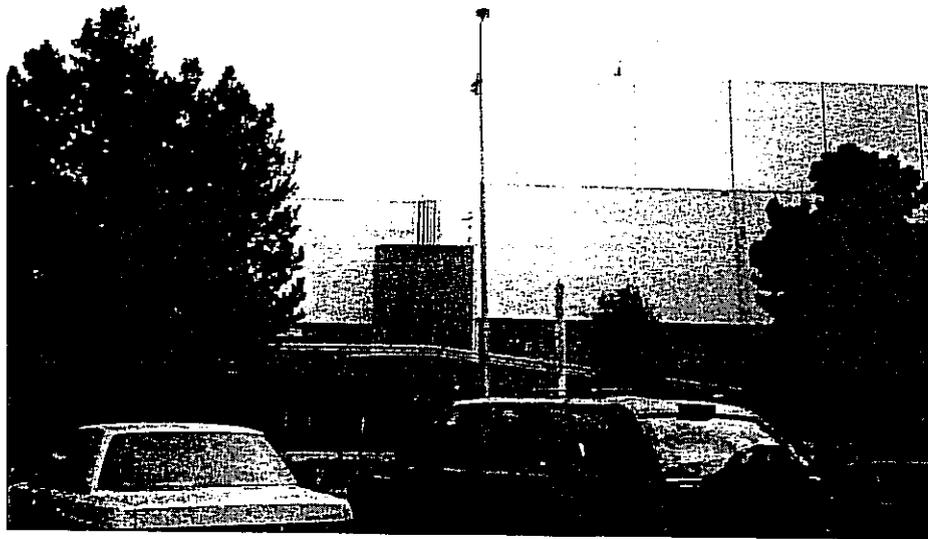
Photo 5. West view of Building 1003 behind, surrounded by Building 10032 in foreground.

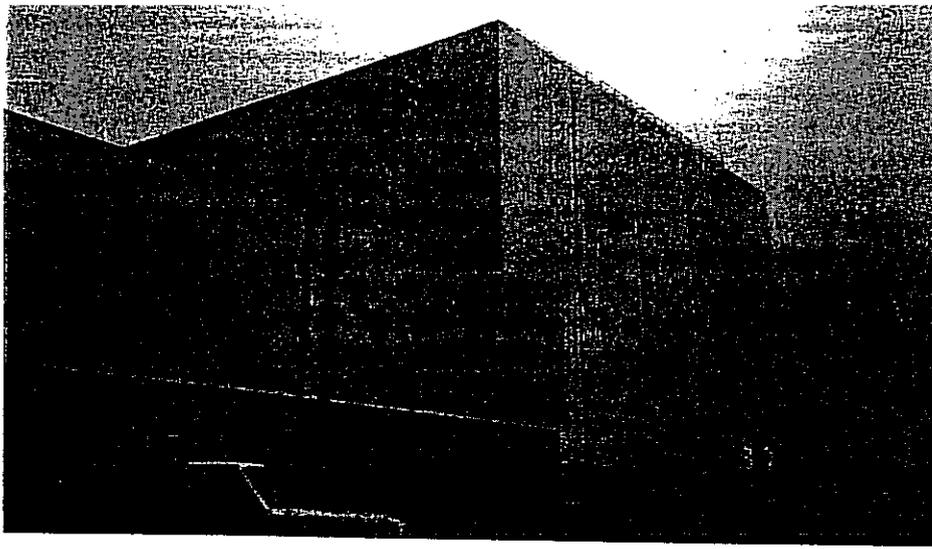
Photo 7. South view of Building 1003 behind, and Building 10032 in foreground.

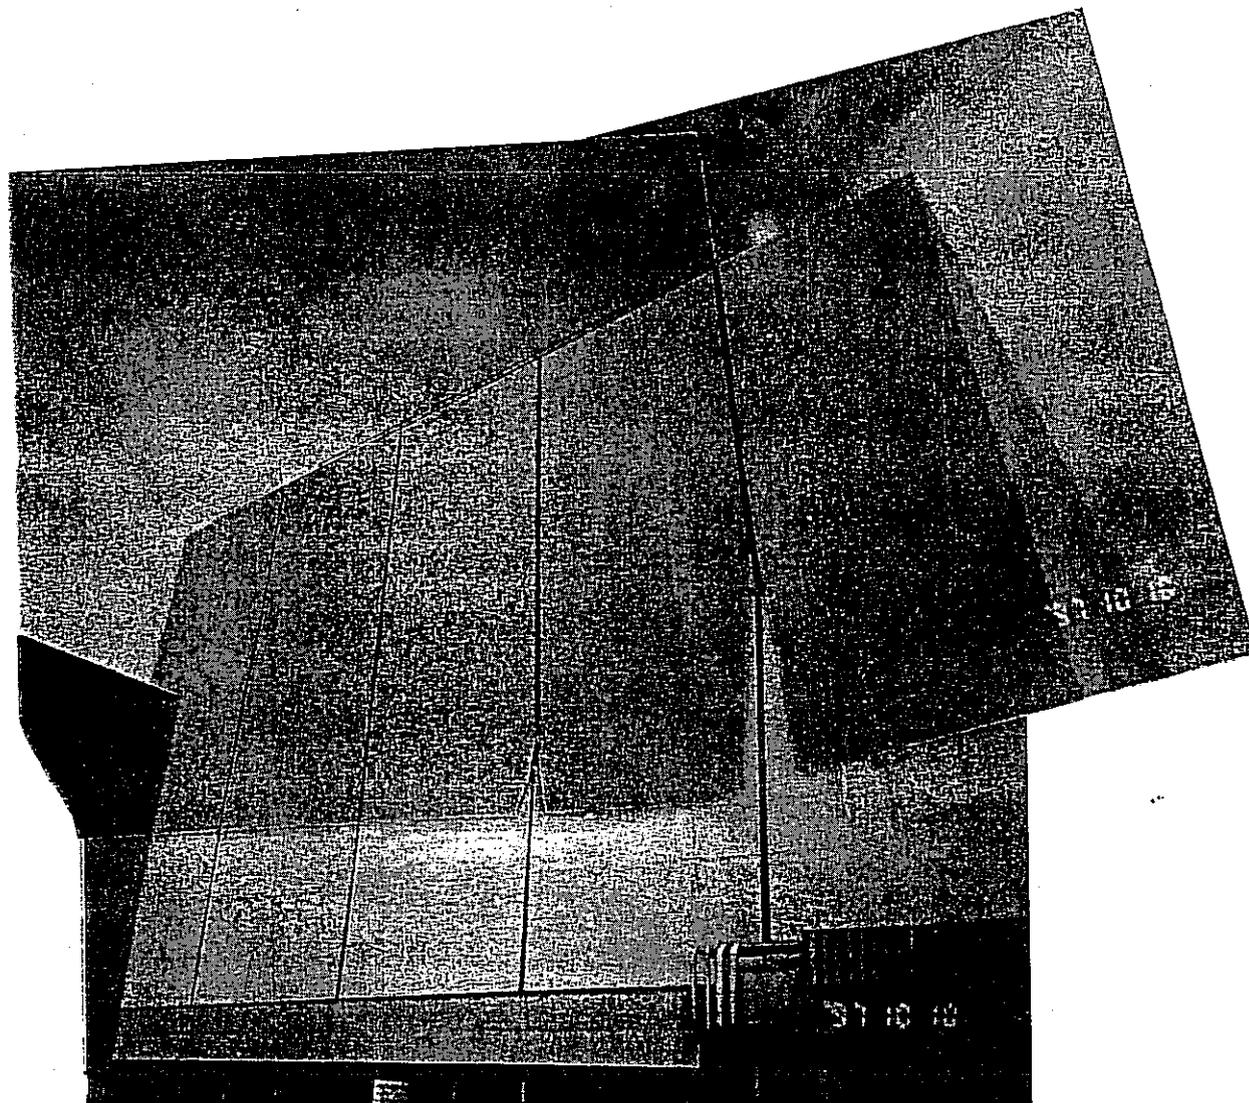
Photo 9. South close-up view of Building 1003.

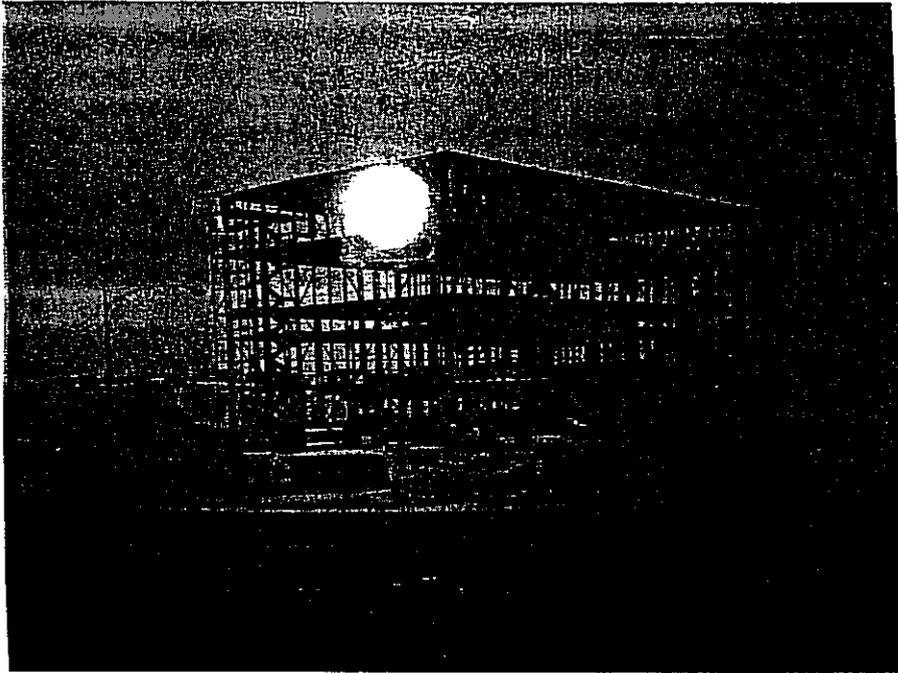
Photo 10. Existing photograph of the construction of Building 1003 as displayed in Lobby. Notice the framing of four story levels with 19 to 25 feet story heights.

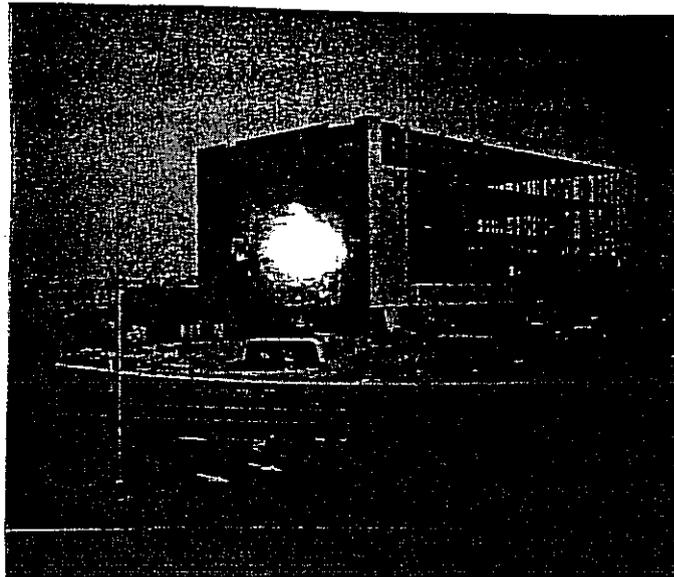
Photo 11. Existing photograph of the construction of Building 1003 as displayed in Lobby. Notice the

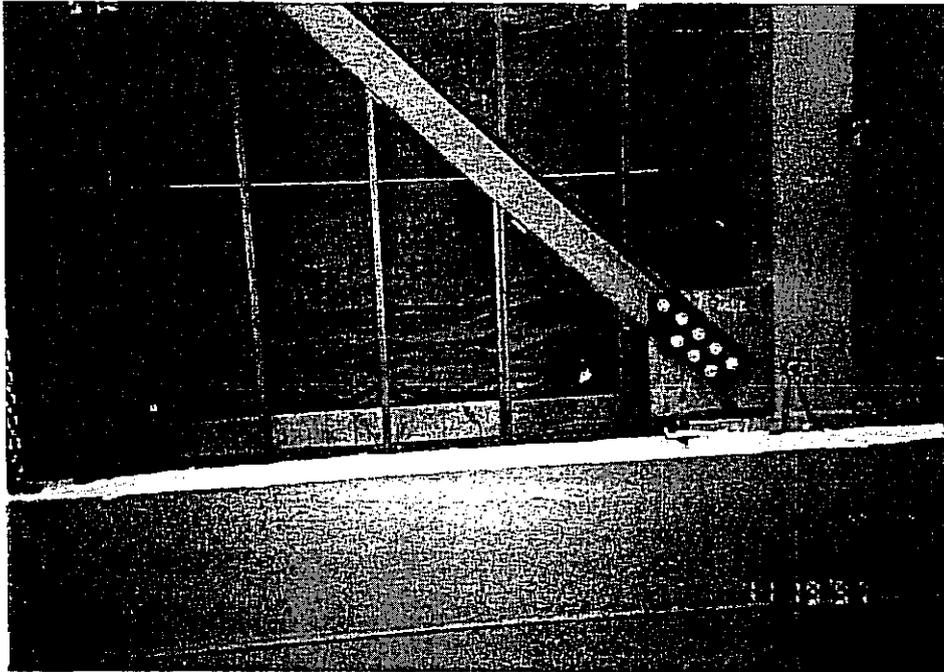
Photo 16. Typical diagonal bracing along building perimeter for lateral shear.

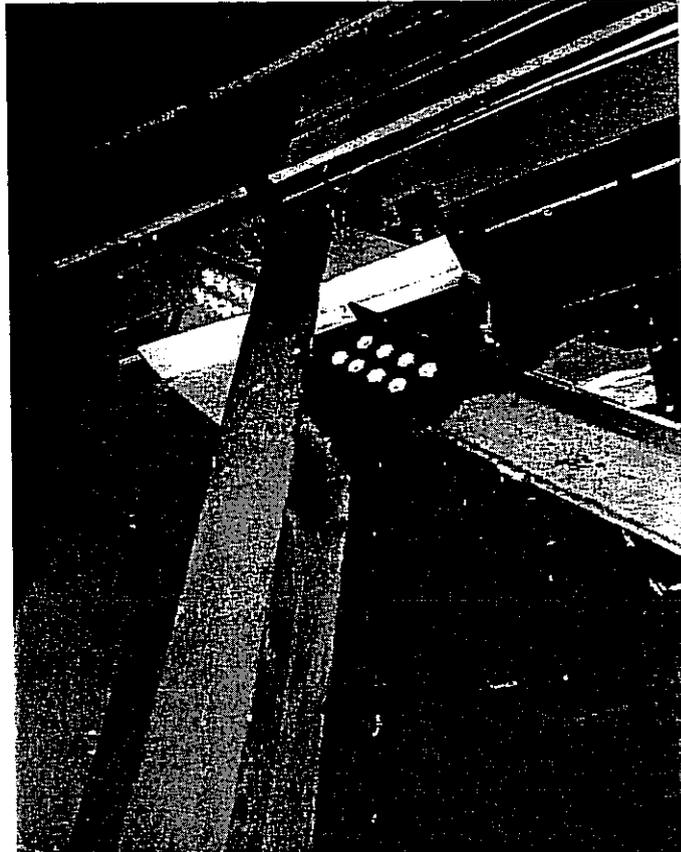
Photo 20. Typical connection of floor beams to column top. Notice the connection is not designed as a moment resistant connection. The steel deck floor is tack welded to the floor joist.

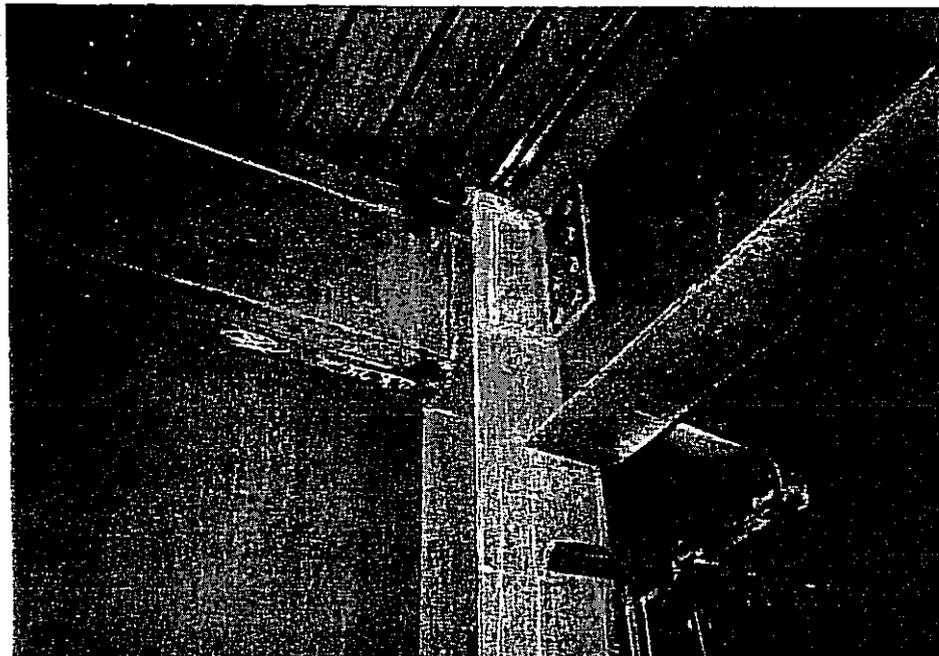
Photo 22. Another view of the connection of floor beams to column top. Again, notice the connection is not designed as a moment resistant connection.

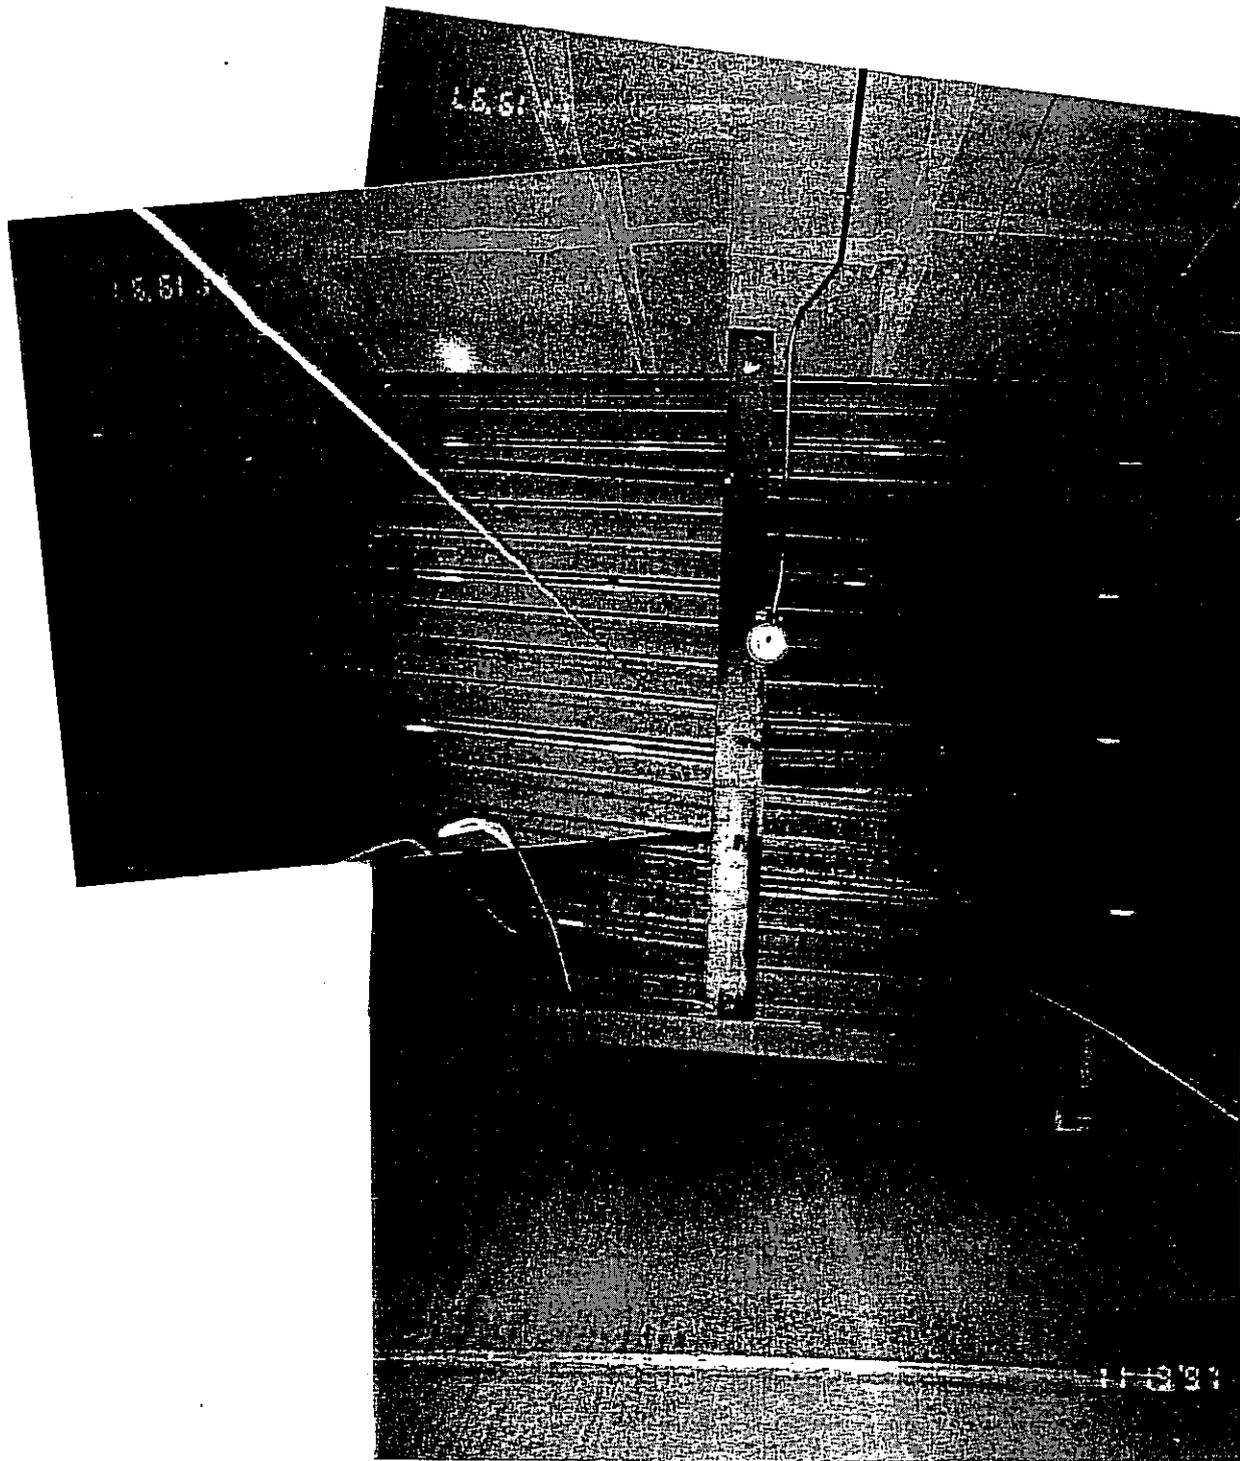
Photo 25 - Underneath view of the typical steel deck floor. The floors consist of a concrete slab over a

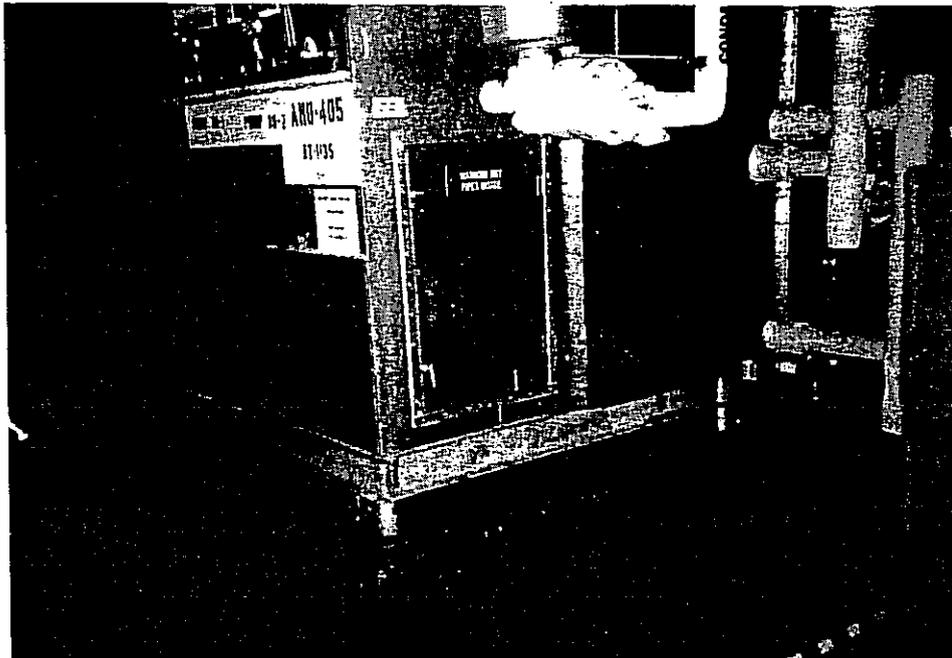
Photo 31. View of different type of anchorage for the mechanical equipment. This one is a rigid anchor type with no allowance for vibration. It connects the equipment rigidly to the foundation.

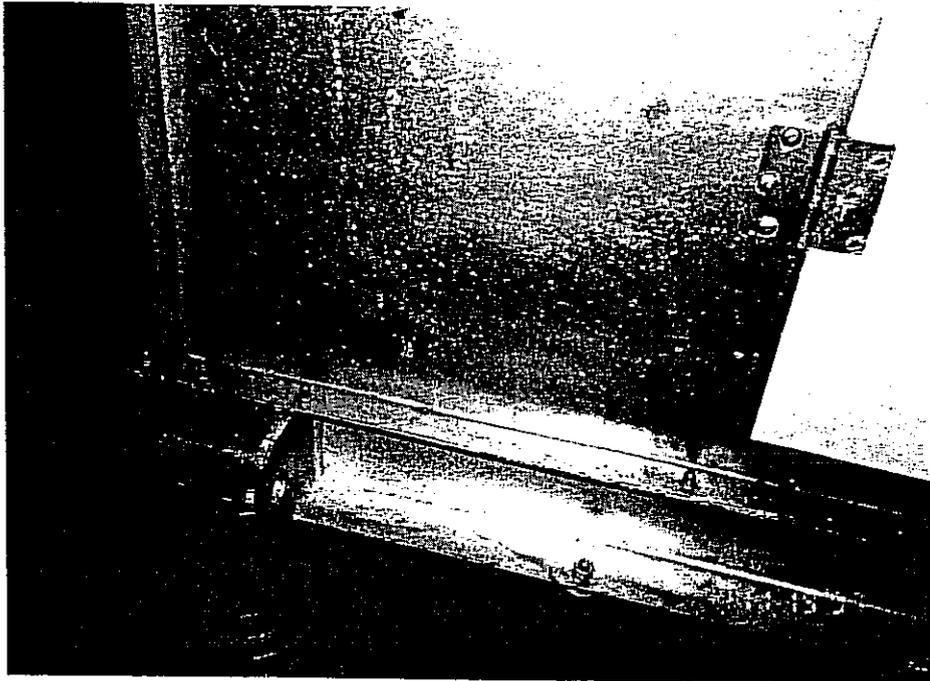
Photo 33. This other type of anchorage for the mechanical equipment provides vibration isolation and allows lateral restraint with a dampening effect. This anchor type is recommended to limit horizontal and vertical motion while absorbing stresses to minimize damage to equipment, piping connections or foundation.

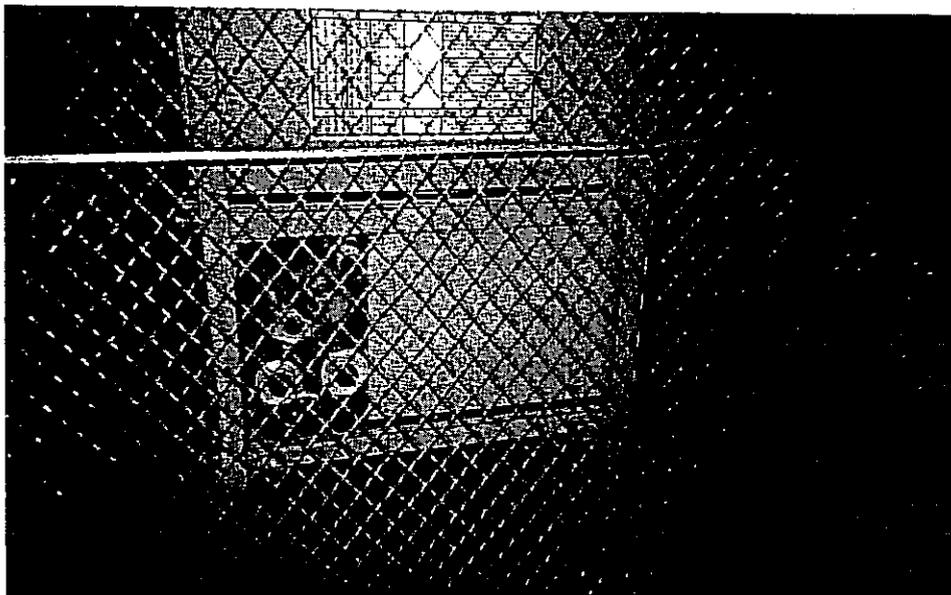
Photo 45. Elevator pumps and motors at elevator equipment room in the fourth floor are properly anchored.

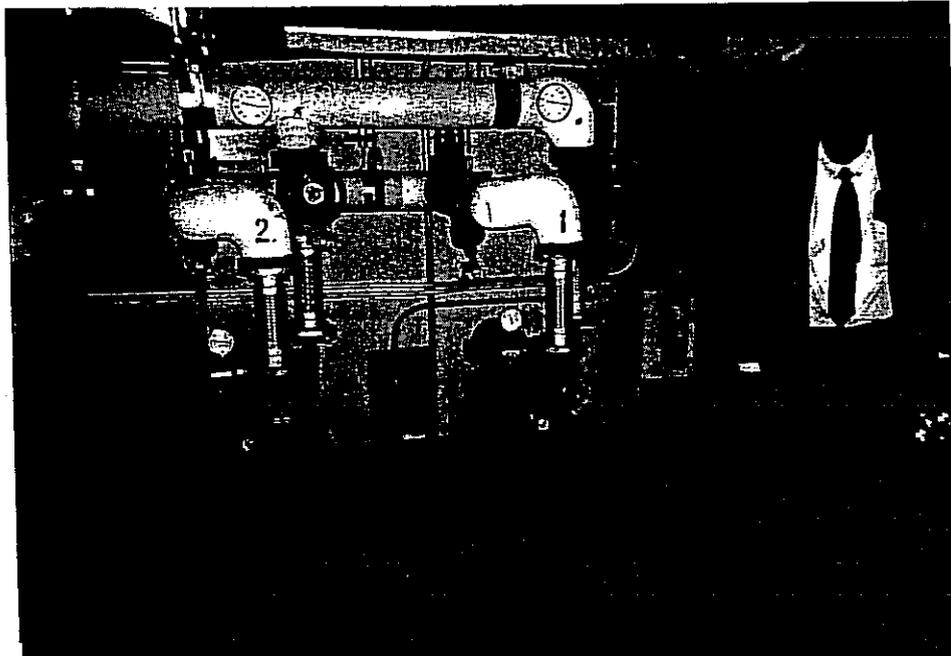
Photo 47. Some pipe crossing through walls do not have flexible joints or sleeves with tolerance for movement. Fire blocking is appropriate but tolerance for movement should be included.
