Library *of the* Future

Existing Facility Assessment

Published Date, December 13, 2006
Revised Date, June 28 2007

ANDERSON BRULÉ ARCHITECTS

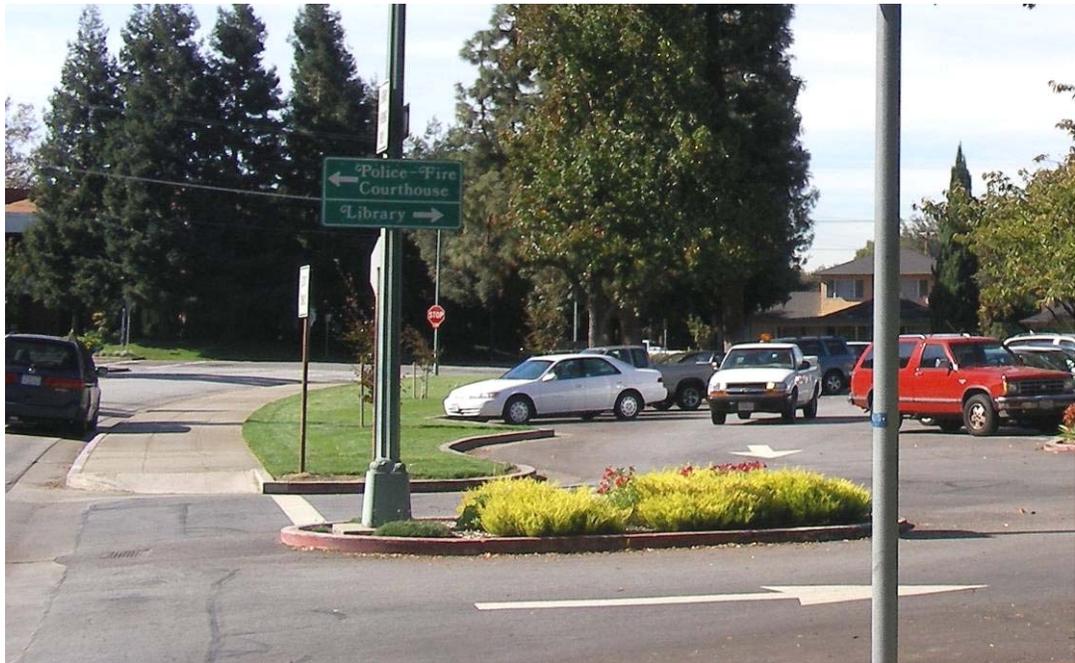
The site is accessible from both West Olive Boulevard and South Pastoria Avenue. The curb cuts and driveway entrances appear to meet current city standards. Small light-post mounted signage for the facility is located at the entrances to the property and directional signage at is located at adjacent intersections to direct the community to the library site.

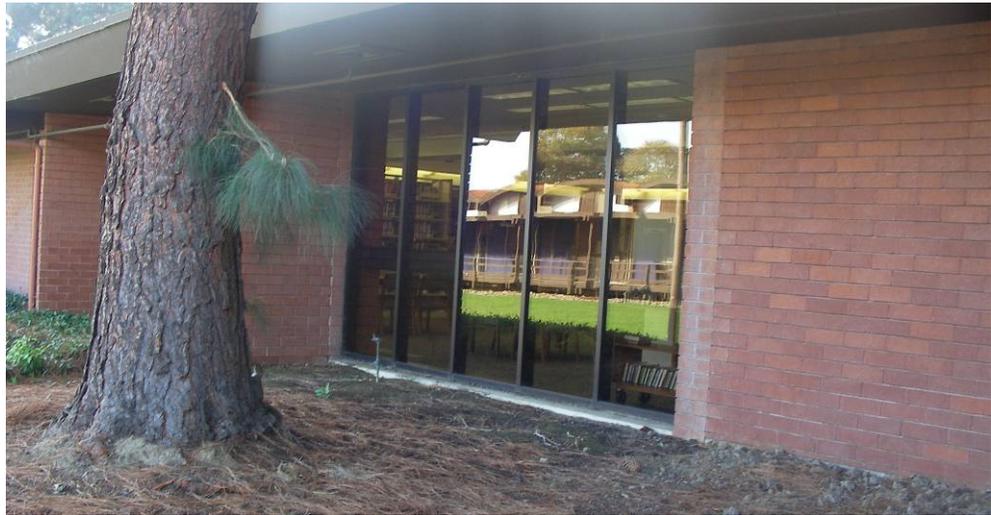
The exterior of the building consists of brick facing and glazed elements, fixed dual pane storefront window and door systems, as well as glass block walls. The existing perimeter window systems allow for a significant amount of natural light entry into the building. Art glass installations exist in some of the window systems that highlight the adjacent reading areas. The windows are fixed, and the exit doors are alarmed for exiting.

There are large overhangs at the perimeter of the building; the eaves are finished with exposed wood siding. There is an existing sprinkler system intact to protect this wood finish from fire damage. There have been problems with gutter blockage that forces water to stream over the edge of the gutter and has caused flooding at the storefront exits in the past.

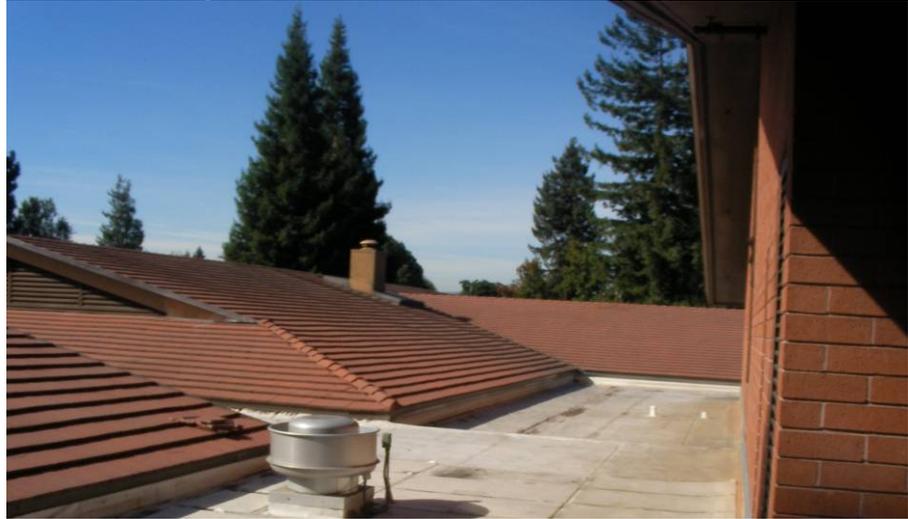
The existing roof finish is concrete tile shingle roofing at the sloped roof areas as well as single-ply sheet roofing at the flat roof areas. Numerous types of skylights and translucent roofing panel installations throughout the facility highlight special features of the building or provide natural light at the joints between the original building footprint and the subsequent additions. There is minor mechanical equipment on the roof, including some exhaust fans and chimney extensions.

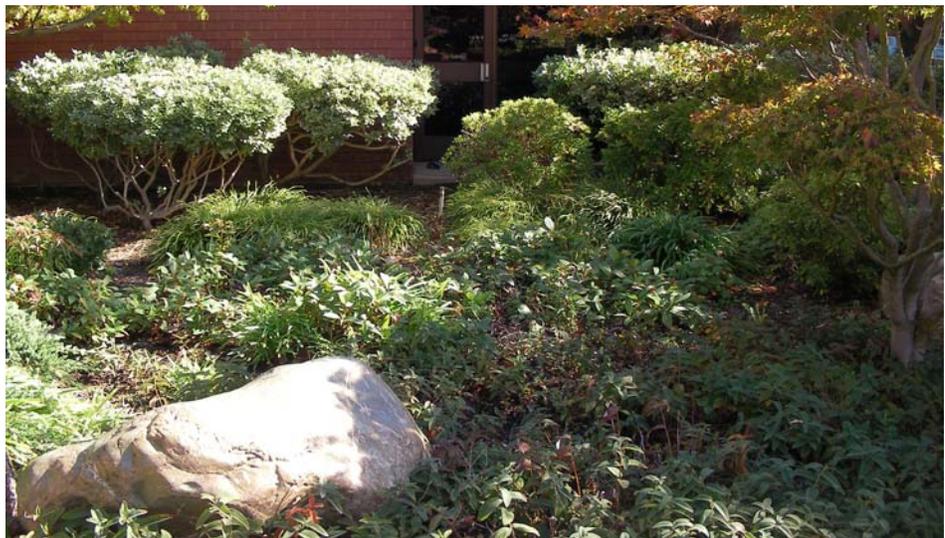
The landscape elements of the building are consistent across the entire property. There is a natural feeling to the landscaped planters, and there are many mature trees on the property. The paving areas are finished with brick and provide for entry procession from the parking areas to the entry of the building. Enclosed courtyards are provided at certain locations around the facility, but do not appear to be accessible as the doors leading out to these spaces seem to be alarmed and for exit use only.

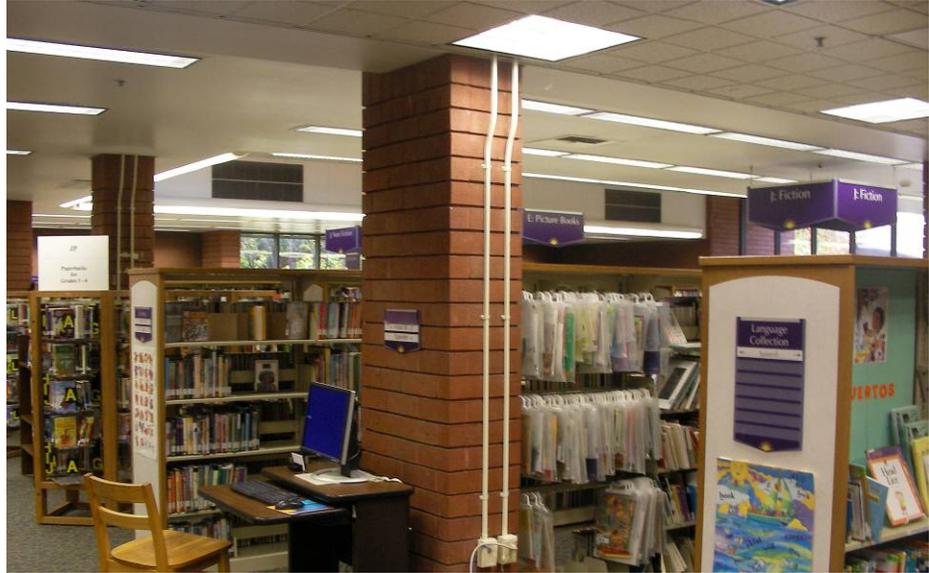
The interior finishes consist of brick wall facing and painted gypsum board wall finish. The ceilings are finished with areas of acoustical ceiling tile direct glued over gypsum board as well as areas of both exposed wood ceiling finish and painted gypsum board ceiling finish.

The existing library is well used by the community of Sunnyvale. The facility and the finishes have worn due to the amount of use the facility receives. In general, the toilet room finishes are worn and damaged. Lighting in the toilet rooms does not appear to be adequate.

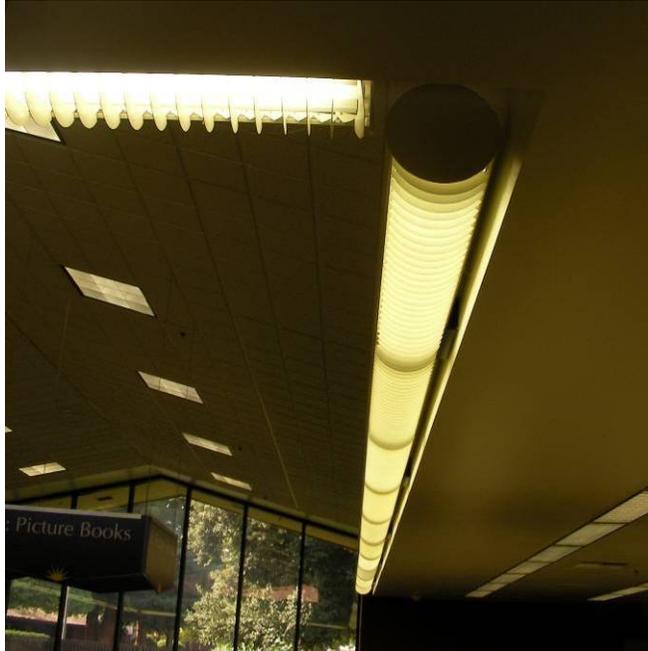
Lighting throughout the facility consists of fluorescent strip fixtures, mostly direct/indirect fixture types. In combination with the natural light, this provides for significant lighting throughout the spaces. The electrical light alone does not appear to adequately illuminate the spaces for appropriate reading light levels, and therefore after dark the building seems very dimly lit.

Exit signage is located at each exit door. Stairs to the mezzanine do not appear to meet current code; the landing at the main entry doors at the mezzanine does not accommodate the appropriate clear distance for accessibility requirements. There is a head-height clearance concern at the underside of the stairway to the mezzanine and there have been temporary measures taken to cover exposed sharp stair handrail post protrusions.
